## General Information

<b>Make</b>	Toyota	<b>Model</b>	Yaris Cross
<b>YOM</b>	2024	<b>Odo Meter Reading</b>	13,132
<b>Registration No.</b>	GBE5930	<b>Chassis No.</b>	MHFAA8AF3R0025480
<b>CC</b>	1.5	<b>Transmission</b>	CVT
<b>Fuel Type</b>	Gas	<b>Type of Body</b>	Wagon
<b>Colour</b>	Black

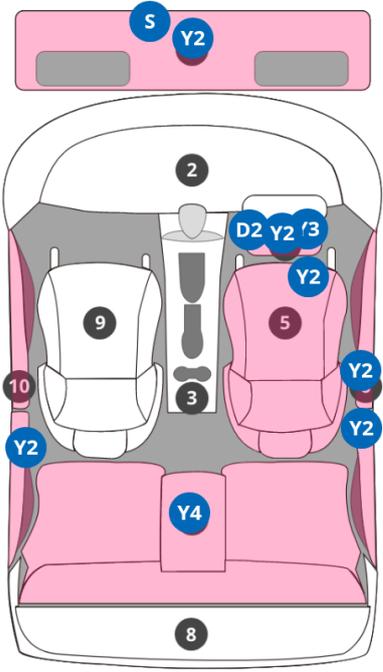
<b>Interior Evaluation :</b> <span style="float: right; color: red; font-weight: bold;">C</span>	<b>Exterior Evaluation :</b> <span style="float: right; color: red; font-weight: bold;">E</span>

<p><b>a</b> : Cut, Fray <b>d</b> : Loose, Deformed <b>k</b> : Animal Hair <b>s</b> : Smell <b>t</b> : Cigarette Burns <b>x</b> : Defective <b>y</b> : Stain</p>

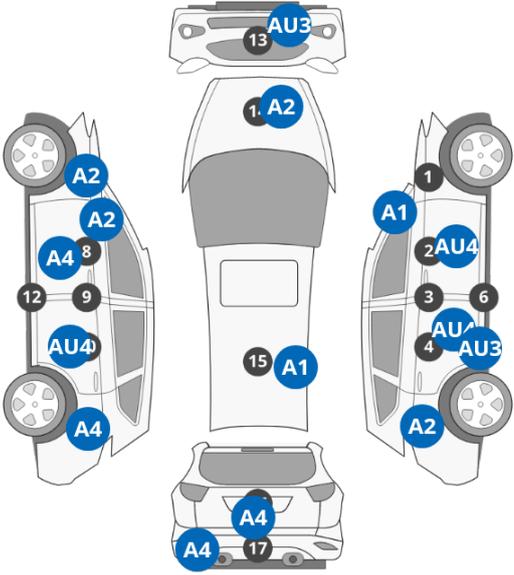
<p><b>A</b> : Scratch <b>AU</b> : Scratch &amp; Dent <b>B</b> : Modified <b>C</b> : Corrosion <b>G</b> : Stone chip <b>P</b> : Faded <b>S</b> : Rust <b>SC</b> : Rust &amp; Corrosion <b>U</b> : Dent <b>X</b> : Defective <b>Y</b> : Crack, Gap</p>
<p><b>Remarks</b> Ceiling - Grime - Small / (R) Front Seat - Grime - Small / (R) Front Floor Mat - Grime - Medium / (R) Front Trim - Grime - Small / (R) Rear Trim - Grime - Small / Rear Seat - Grime - Large / Mat Other - Grime - Small / (L) Rear Trim - Grime - Small / (L) Front Floor Mat - Worked - Small / Overall Interior - Smell - Yes</p>	<p><b>Remarks</b> (R) Front Door, Molding - Scratch &amp; Dent - Large / (R) Rear Door, Molding - Scratch &amp; Dent - Large / (R) Mirror - Scratch - Minimal / (R) Rear Fender, Molding - Scratch - Small / (R) Step, In-panel, Side Spoiler - Scratch &amp; Dent - Medium / Trunk Hood, Rear Gate - Scratch - Large / Rear Bumper, Lamps, Panels - Scratch - Large / (L) Rear Fender, Molding - Scratch - Large / (L) Rear Door, Molding - Scratch &amp; Dent - Large / (L) Front Door, Molding - Scratch - Large / (L) Mirror - Scratch - Small / (L) Front Fender, Molding - Scratch - Small / Bonnet, Headlight - Scratch - Small / Front Bumper, Grille, Lamps - Scratch &amp; Dent - Medium / Roof - Scratch - Minimal</p>
