## General Information

<b>Make</b>	Toyota	<b>Model</b>	Vios
<b>YOM</b>	2024	<b>Odo Meter Reading</b>	1,076
<b>Registration No.</b>	GBE8341	<b>Chassis No.</b>	PA1B18F35R4254089
<b>CC</b>	1.3	<b>Transmission</b>	CVT
<b>Fuel Type</b>	Gas	<b>Type of Body</b>	Sedan
<b>Colour</b>	Silver

## Body / Panel Condition

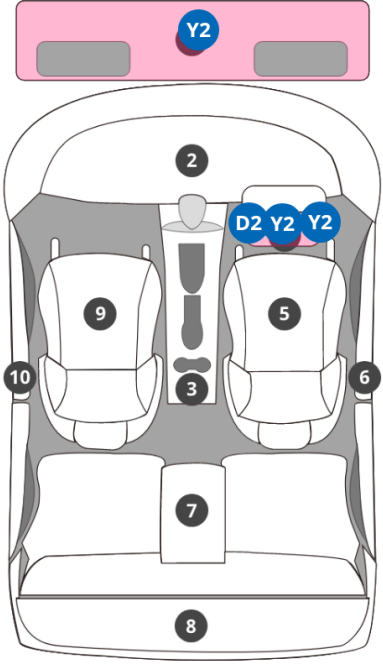
<p><b>a</b> : Cut, Fray <b>d</b> : Loose, Deformed <b>k</b> : Animal Hair <b>s</b> : Smell <b>t</b> : Cigarette Burns <b>x</b> : Defective <b>y</b> : Stain</p>

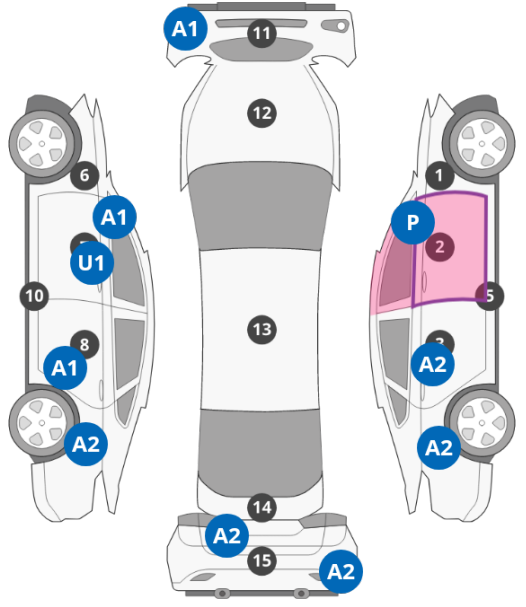
<p><b>A</b> : Scratch <b>AU</b> : Scratch &amp; Dent <b>B</b> : Modified <b>C</b> : Corrosion <b>G</b> : Stone chip <b>P</b> : Faded <b>S</b> : Rust <b>SC</b> : Rust &amp; Corrosion <b>U</b> : Dent <b>X</b> : Defective <b>Y</b> : Crack, Gap</p>
<p><b>Remarks</b> Ceiling - Grime - Small / Mat Other - Grime - Small / (L) Front Floor Mat - Worked - Small / (R) Front Floor Mat - Grime - Small</p>	<p><b>Remarks</b> (R) Front Door - Repair Traces - Yes / (R) Front Door, Molding - Partially Missing - Yes / (R) Front Door, Molding - Repair mark - Yes / (R) Mirror - Faded(Color, Gloss) - Yes / (R) Rear Fender, Molding - Scratch - Small / (R) Rear Door, Molding - Scratch - Small / Trunk Hood, Rear Gate - Scratch - Small / Rear Bumper, Lamps, Panels - Scratch - Small / (L) Rear Fender, Molding - Scratch - Small / (L) Front Door, Molding - Dent - Minimal / (L) Rear Door, Molding - Scratch - Minimal / (L) Mirror - Scratch - Minimal / Front Bumper, Grille, Lamps - Scratch - Minimal</p>
