General Information

Make	Toyota	Model	Veloz
YOM	2024	Odo Meter Reading	11,158
Registration No.	GBE5799	Chassis No.	MHFAB1BY6R3103916
CC	1.5	Transmission	CVT
Fuel Type	Gas	Type of Body	SUV
Colour	Red Mica Metallic

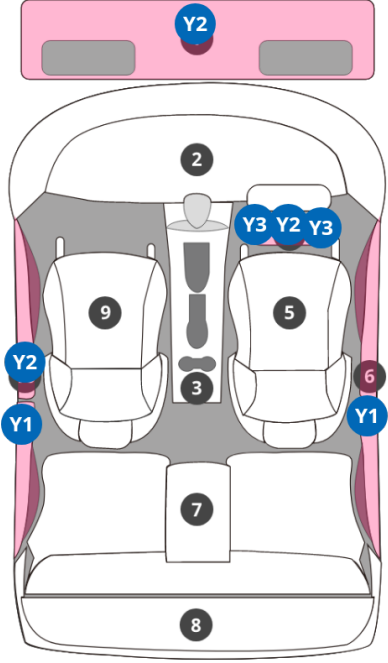
Interior Evaluation : B	Exterior Evaluation : E

<p>a : Cut, Fray d : Loose, Deformed k : Animal Hair s : Smell t : Cigarette Burns x : Defective y : Stain</p>

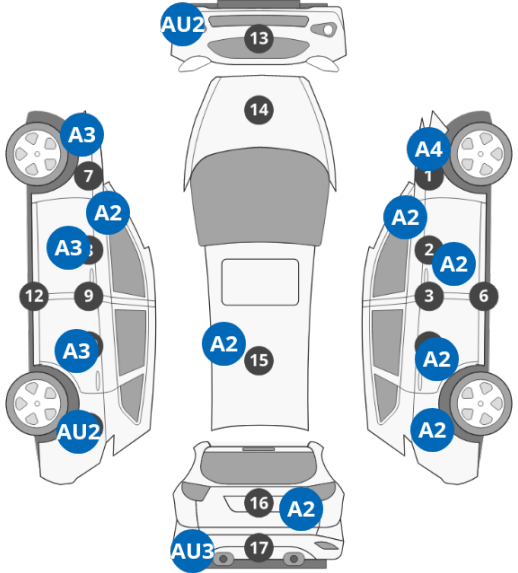
<p>A : Scratch AU : Scratch & Dent B : Modified C : Corrosion G : Stone chip P : Faded S : Rust SC : Rust & Corrosion U : Dent X : Defective Y : Crack, Gap</p>
<p>Remarks (L) Front Floor Mat - Grime - Medium / (L) Front Trim - Grime - Small / (L) Rear Trim - Grime - Minimal / Mat Other - Grime - Small / Ceiling - Grime - Small / (R) Rear Trim - Grime - Minimal / (R) Front Floor Mat - Grime - Medium</p>	<p>Remarks (L) Front Fender, Molding - Scratch - Medium / (L) Mirror - Scratch - Small / (L) Front Door, Molding - Scratch - Medium / (L) Rear Door, Molding - Scratch - Medium / (L) Rear Fender, Molding - Scratch & Dent - Small / Trunk Hood, Rear Gate - Scratch - Small / Rear Bumper, Lamps, Panels - Scratch & Dent - Medium / (R) Rear Fender, Molding - Scratch - Small / (R) Rear Door, Molding - Scratch - Small / (R) Front Door, Molding - Scratch - Small / (R) Mirror - Scratch - Small / (R) Front Fender, Molding - Scratch - Large / Front Bumper, Grille, Lamps - Scratch & Dent - Small / Roof - Scratch - Small</p>
