General Information

Make	Toyota	Model	Vios
YOM	2020	Odo Meter Reading	87,364
Registration No.	GAO8519	Chassis No.	PA1B18F35L4117208
CC	1.3	Transmission	M/T
Fuel Type	Gas	Type of Body	Sedan
Colour	Green

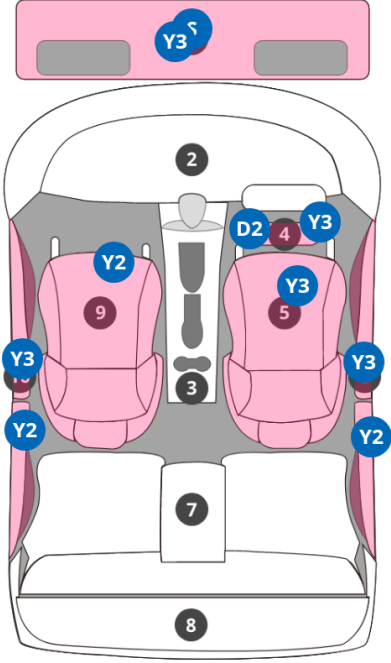
Interior Evaluation : C	Exterior Evaluation : D

<p>a : Cut, Fray d : Loose, Deformed k : Animal Hair s : Smell t : Cigarette Burns x : Defective y : Stain</p>

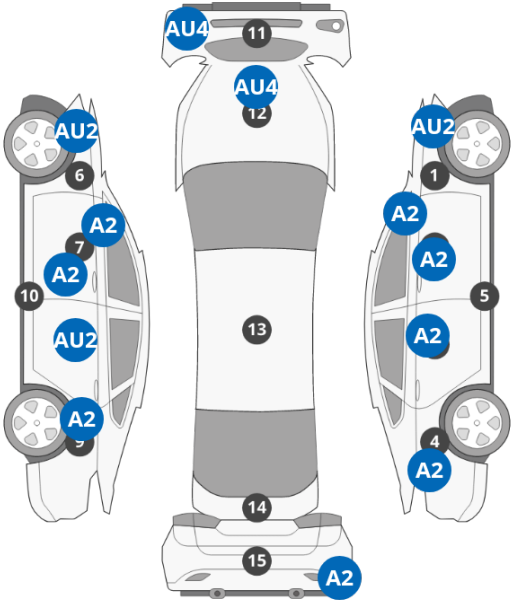
<p>A : Scratch AU : Scratch & Dent B : Modified C : Corrosion G : Stone chip P : Faded S : Rust SC : Rust & Corrosion U : Dent X : Defective Y : Crack, Gap</p>
<p>Remarks (L) Front Floor Mat - Worked - Small / Overall Interior - Smell - Yes / (R) Front Floor Mat - Grime - Medium / (R) Front Seat - Grime - Medium / (R) Front Trim - Grime - Medium / (R) Rear Trim - Grime - Small / (L) Rear Trim - Grime - Small / (L) Front Trim - Grime - Medium / (L) Front Seat - Grime - Small / Ceiling - Grime - Medium</p>	<p>Remarks Bonnet, Headlight - Scratch & Dent - Large / (R) Mirror - Scratch - Small / (R) Front Door, Molding - Scratch - Small / (R) Rear Door, Molding - Scratch - Small / (R) Front Fender, Molding - Scratch & Dent - Small / (R) Rear Fender, Molding - Scratch - Small / Rear Bumper, Lamps, Panels - Scratch - Small / (L) Rear Fender, Molding - Scratch - Small / (L) Rear Door, Molding - Scratch & Dent - Small / (L) Front Door, Molding - Scratch - Small / (L) Front Fender, Molding - Scratch & Dent - Small / (L) Mirror - Scratch - Small / Front Bumper, Grille, Lamps - Scratch & Dent - Large</p>
