## General Information

| Make | Toyota | Model | Vios |

## Body / Panel Condition

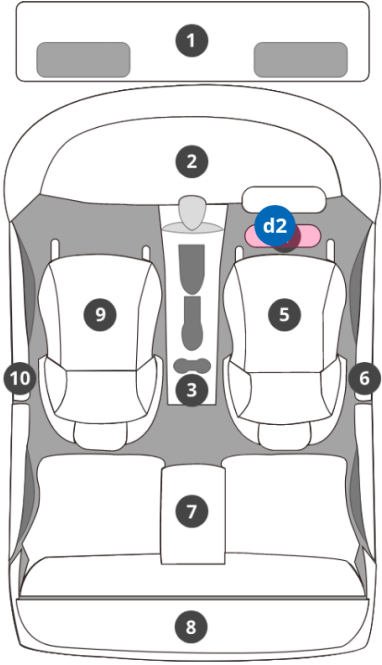
| Interior Evaluation : <span style="color: red;">A</span> | Exterior Evaluation : <span style="color: red;">D</span> |
| <b>Remarks</b><br>Mat Other - Worked - Small / Overall Interior - Worn as per age - Yes | <b>Remarks</b><br>Member (Bolted) - Dent - Yes / Front Bumper, Grille, Lamps - Scratch & Dent - Large / Bonnet, Headlight - Scratch & Dent - Medium / (R) Front Fender, Molding - Dent - Small / (R) Rear Fender, Molding - Dent - Medium / Rear Bumper, Lamps, Panels - Scratch & Dent - Medium / (L) Rear Fender, Molding - Scratch & Dent - Medium / (R) Rear Door, Molding - Scratch - Small / Roof - Dent - Small / (L) Front Door, Molding - Scratch - Medium |

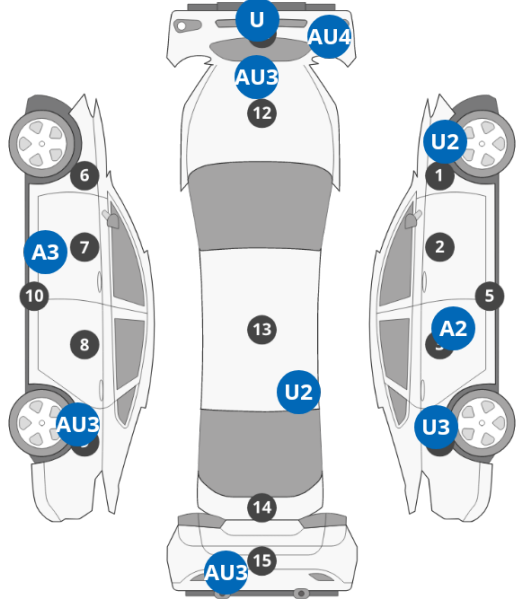
| Interior Evaluation : <span style="color: red;">A</span> | Exterior Evaluation : <span style="color: red;">D</span> |
|---|---|
| <b>Remarks</b><br>Front Cross Member Support - Traces of Bending, or Marks of Panel Repair ? - Yes | <b>Remarks</b><br>Reverse Camera - N/A - Yes / Spare Key - Issue - Unexist |

| Inspector Notes |
|---|
| broken headlight/ hood cannot be closed/ gap on the front bumper/ with tools and spare tire and jack/ no warranty booklet |
