General Information

Make	Toyota	Model	Vios
YOM	2025	Odo Meter Reading	33,781
Registration No.	GBD8479	Chassis No.	PA1B18F36R4270012
CC	1.3	Transmission	CVT
Fuel Type	Gas	Type of Body	Sedan
Colour	Silver

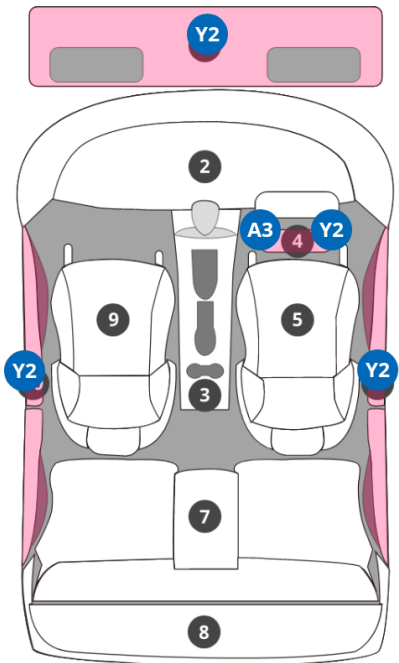
Interior Evaluation : B	Exterior Evaluation : C

<p>a : Cut, Fray d : Loose, Deformed k : Animal Hair s : Smell t : Cigarette Burns x : Defective y : Stain</p>

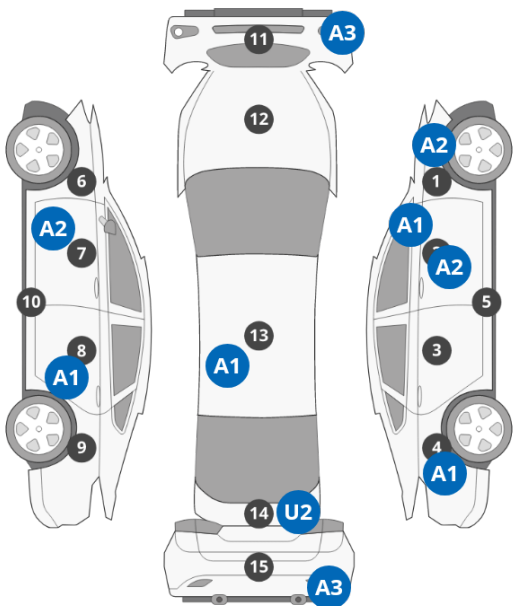
<p>A : Scratch AU : Scratch & Dent B : Modified C : Corrosion G : Stone chip P : Faded S : Rust SC : Rust & Corrosion U : Dent X : Defective Y : Crack, Gap</p>
<p>Remarks Ceiling - Grime - Small / (R) Front Trim - Grime - Small / (R) Front Floor Mat - Grime - Small / (L) Front Trim - Grime - Small / (L) Front Floor Mat - Cut, Crack - Medium</p>	<p>Remarks (L) Front Door, Molding - Scratch - Small / Front Bumper, Grille, Lamps - Scratch - Medium / (R) Front Fender, Molding - Scratch - Small / (R) Mirror - Scratch - Minimal / (R) Front Door, Molding - Scratch - Small / (R) Rear Fender, Molding - Scratch - Minimal / Trunk Hood, Rear Gate - Dent - Small / Rear Bumper, Lamps, Panels - Scratch - Medium / (L) Rear Door, Molding - Scratch - Minimal / Roof - Scratch - Minimal</p>
