General Information

Make	Toyota	Model	Vios
YOM	2025	Odo Meter Reading	9,835
Registration No.	GBI2319	Chassis No.	PA1B18F34R4277346
CC	1.3	Transmission	CVT
Fuel Type	Gas	Type of Body	Sedan
Colour	Red Mica Metallic

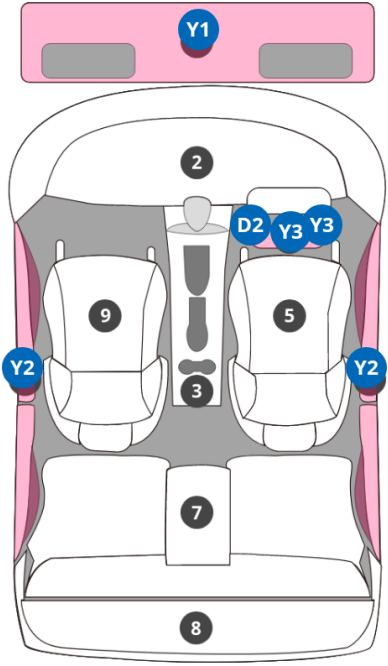
<p>a : Cut, Fray d : Loose, Deformed k : Animal Hair s : Smell t : Cigarette Burns x : Defective y : Stain</p>

<p>A : Scratch AU : Scratch & Dent B : Modified C : Corrosion G : Stone chip P : Faded S : Rust SC : Rust & Corrosion U : Dent X : Defective Y : Crack, Gap</p>
<p>Remarks (L) Front Trim - Grime - Small / (L) Front Floor Mat - Worked - Small / Mat Other - Grime - Medium / (R) Front Floor Mat - Grime - Medium / (R) Front Trim - Grime - Small / Ceiling - Grime - Minimal</p>	<p>Remarks (R) Mirror - Scratch - Minimal / (R) Front Fender, Molding - Scratch - Medium / Bonnet, Headlight - Scratch - Small / Front Bumper, Grille, Lamps - Scratch - Medium / (L) Front Fender, Molding - Scratch - Small / (L) Mirror - Scratch - Minimal / (L) Front Door, Molding - Scratch - Medium / (L) Rear Door, Molding - Scratch - Medium / (L) Step, In-panel, Side Spoiler - Scratch - Small / (L) Rear Fender, Molding - Scratch - Small / Trunk Hood, Rear Gate - Scratch - Large / Rear Bumper, Lamps, Panels - Scratch - Small / (R) Rear Fender, Molding - Scratch - Large / (R) Rear Door, Molding - Scratch & Dent - Large / (R) Front Door, Molding - Scratch - Minimal / Roof - Scratch - Minimal</p>
