General Information

Make	Toyota	Model	Vios
YOM	2023	Odo Meter Reading	17,896
Registration No.	GAP2001	Chassis No.	PA1B18F31N4192412
CC	1.3	Transmission	M/T
Fuel Type	Gas	Type of Body	Sedan
Colour	Blue

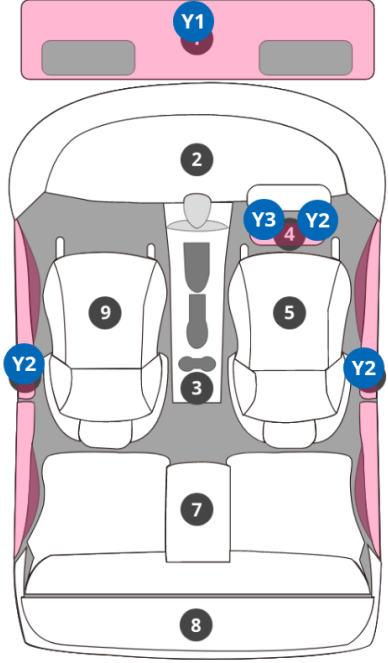
Interior Evaluation : B	Exterior Evaluation : C

<p>a : Cut, Fray d : Loose, Deformed k : Animal Hair s : Smell t : Cigarette Burns x : Defective y : Stain</p>

<p>A : Scratch AU : Scratch & Dent B : Modified C : Corrosion G : Stone chip P : Faded S : Rust SC : Rust & Corrosion U : Dent X : Defective Y : Crack, Gap</p>
<p>Remarks (R) Front Floor Mat - Grime - Small / (R) Front Trim - Grime - Small / Ceiling - Grime - Minimal / (L) Front Trim - Grime - Small / (L) Front Floor Mat - Grime - Medium</p>	<p>Remarks (R) Rear Door, Molding - Scratch - Medium / (R) Rear Fender, Molding - Scratch - Minimal / Trunk Hood, Rear Gate - Scratch - Small / Rear Bumper, Lamps, Panels - Scratch - Small / (L) Rear Fender, Molding - Scratch - Minimal / (L) Rear Door, Molding - Scratch - Small / (L) Front Fender, Molding - Scratch - Minimal / (L) Mirror - Scratch - Small / (L) Front Door, Molding - Scratch - Small / Front Bumper, Grille, Lamps - Scratch - Medium</p>
