General Information

Make	Toyota	Model	Vios
YOM	2023	Odo Meter Reading	37,088
Registration No.	GAK8596	Chassis No.	PA1B18F39P4212277
CC	1.3	Transmission	CVT
Fuel Type	Gas	Type of Body	Sedan
Colour	Red Mica Metallic

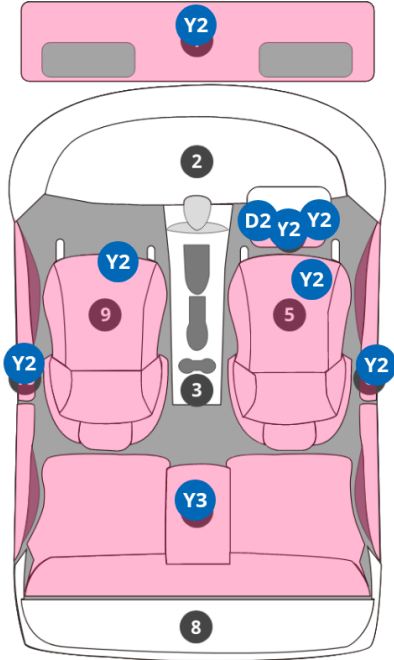
Interior Evaluation : C	Exterior Evaluation : E

<p>a : Cut, Fray d : Loose, Deformed k : Animal Hair s : Smell t : Cigarette Burns x : Defective y : Stain</p>

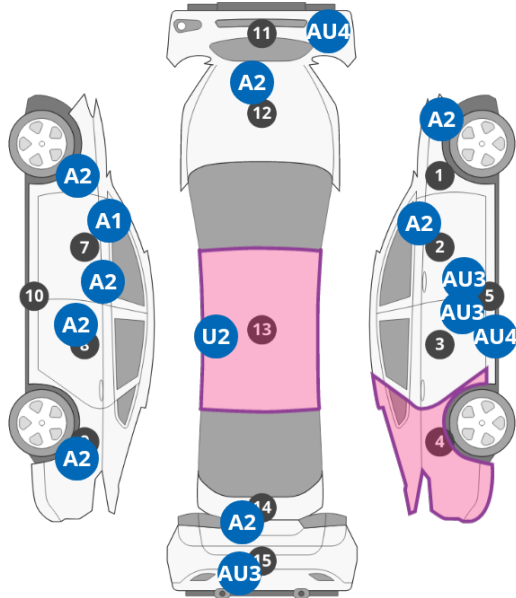
<p>A : Scratch AU : Scratch & Dent B : Modified C : Corrosion G : Stone chip P : Faded S : Rust SC : Rust & Corrosion U : Dent X : Defective Y : Crack, Gap</p>
<p>Remarks Ceiling - Grime - Small / (R) Front Trim - Grime - Small / (R) Front Floor Mat - Grime - Small / (R) Front Seat - Grime - Small / Rear Seat - Grime - Medium / Mat Other - Grime - Small / (L) Front Trim - Grime - Small / (L) Front Floor Mat - Worked - Small / (L) Front Seat - Grime - Small</p>	<p>Remarks (R) Step - Repair Traces - Yes / (R) Rear Fender - Repair Traces - Yes / (R) Rear Door - Repair Traces - Yes / (R) Rear Fender, Molding - Repair mark - Yes / Roof - Repair mark - Yes / Rear Bumper, Lamps, Panels - Scratch & Dent - Medium / Trunk Hood, Rear Gate - Scratch - Small / (L) Rear Fender, Molding - Scratch - Small / (L) Rear Door, Molding - Scratch - Small / (L) Front Door, Molding - Scratch - Small / (L) Mirror - Scratch - Minimal / (L) Front Fender, Molding - Scratch - Small / Front Bumper, Grille, Lamps - Scratch & Dent - Large / Bonnet, Headlight - Scratch - Small / (R) Front Fender, Molding - Scratch - Small / (R) Mirror - Scratch - Small / (R) Front Door, Molding - Scratch & Dent - Medium / (R) Rear Door, Molding - Scratch & Dent - Medium / (R) Step, In-panel, Side Spoiler - Scratch & Dent - Large / Roof - Dent - Small</p>
