## General Information

<b>Make</b>	Toyota	<b>Model</b>	Vios
<b>YOM</b>	2023	<b>Odo Meter Reading</b>	33,318
<b>Registration No.</b>	GAK9821	<b>Chassis No.</b>	PA1B18F32P4214226
<b>CC</b>	1.3	<b>Transmission</b>	CVT
<b>Fuel Type</b>	Gas	<b>Type of Body</b>	Sedan
<b>Colour</b>	Green

## Body / Panel Condition

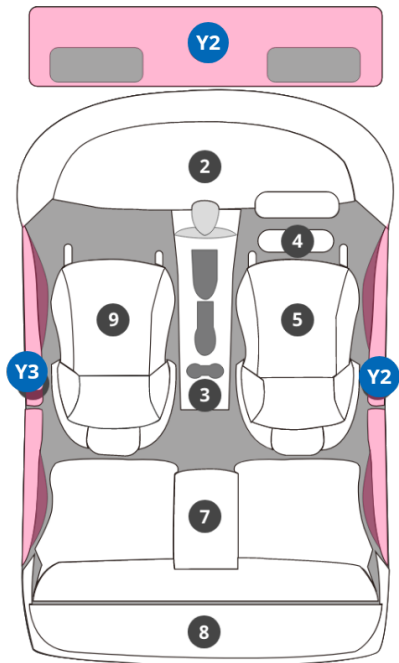
<b>Interior Evaluation :</b> <span style="float: right; color: red; font-weight: bold;">B</span>	<b>Exterior Evaluation :</b> <span style="float: right; color: red; font-weight: bold;">D</span>

<p><b>a</b> : Cut, Fray <b>d</b> : Loose, Deformed <b>k</b> : Animal Hair <b>s</b> : Smell <b>t</b> : Cigarette Burns <b>x</b> : Defective <b>y</b> : Stain</p>

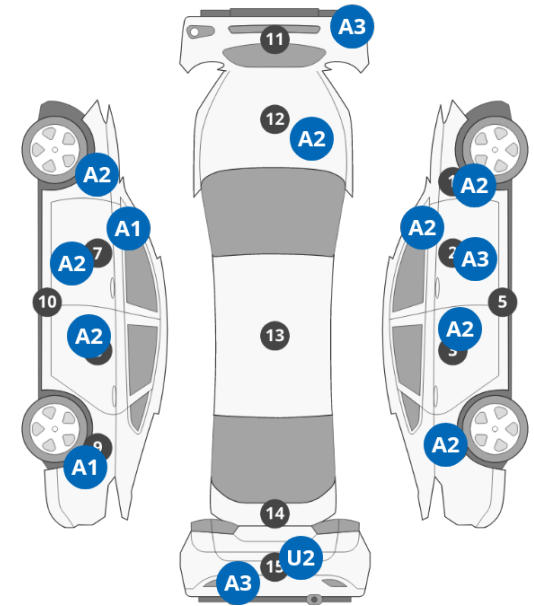
<p><b>A</b> : Scratch <b>AU</b> : Scratch &amp; Dent <b>B</b> : Modified <b>C</b> : Corrosion <b>G</b> : Stone chip <b>P</b> : Faded <b>S</b> : Rust <b>SC</b> : Rust &amp; Corrosion <b>U</b> : Dent <b>X</b> : Defective <b>Y</b> : Crack, Gap</p>
<p><b>Remarks</b> (R) Front Trim - Grime - Small / (L) Front Trim - Grime - Medium / Ceiling - Grime - Small</p>	<p><b>Remarks</b> (R) Front Fender, Molding - Scratch - Small / (R) Mirror - Scratch - Small / (R) Front Door, Molding - Scratch - Medium / (R) Rear Fender, Molding - Scratch - Small / (R) Rear Door, Molding - Scratch - Small / Rear Bumper, Lamps, Panels - Scratch - Medium / Trunk Hood, Rear Gate - Dent - Small / (L) Rear Fender, Molding - Scratch - Minimal / (L) Rear Door, Molding - Scratch - Small / (L) Mirror - Scratch - Minimal / (L) Front Door, Molding - Scratch - Small / (L) Front Fender, Molding - Scratch - Small / Front Bumper, Grille, Lamps - Scratch - Medium / Bonnet, Headlight - Scratch - Small</p>
