## General Information

<b>Make</b>	Toyota	<b>Model</b>	Vios
<b>YOM</b>	2023	<b>Odo Meter Reading</b>	30,097
<b>Registration No.</b>	Z5V783	<b>Chassis No.</b>	PA1B18F38P4220418
<b>CC</b>	1.3	<b>Transmission</b>	CVT
<b>Fuel Type</b>	Gas	<b>Type of Body</b>	Sedan
<b>Colour</b>	Red

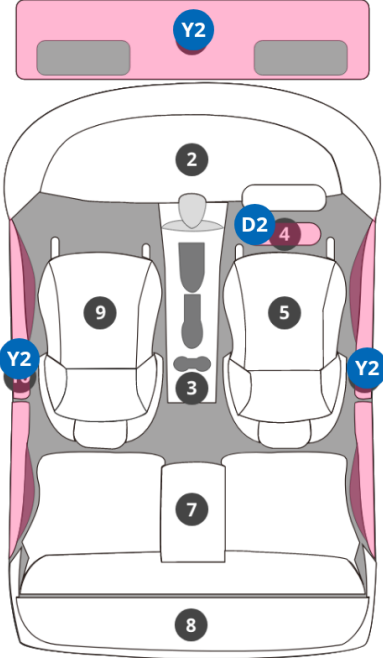
<b>Interior Evaluation :</b> <span style="float: right; color: red; font-weight: bold;">A</span>	<b>Exterior Evaluation :</b> <span style="float: right; color: red; font-weight: bold;">C</span>

<p><b>a</b> : Cut, Fray <b>d</b> : Loose, Deformed <b>k</b> : Animal Hair <b>s</b> : Smell <b>t</b> : Cigarette Burns <b>x</b> : Defective <b>y</b> : Stain</p>

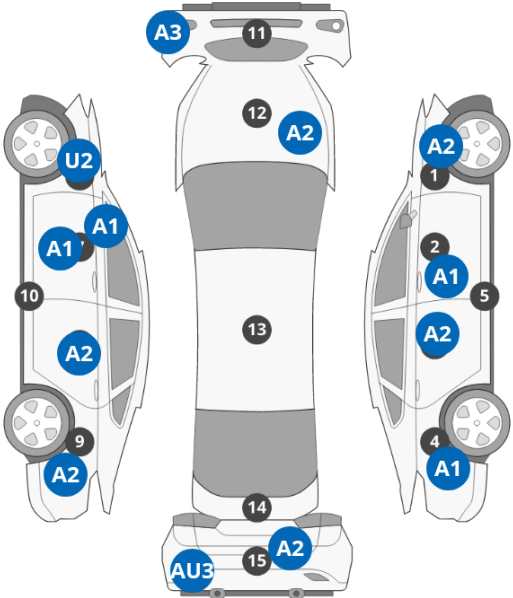
<p><b>A</b> : Scratch <b>AU</b> : Scratch &amp; Dent <b>B</b> : Modified <b>C</b> : Corrosion <b>G</b> : Stone chip <b>P</b> : Faded <b>S</b> : Rust <b>SC</b> : Rust &amp; Corrosion <b>U</b> : Dent <b>X</b> : Defective <b>Y</b> : Crack, Gap</p>
<p><b>Remarks</b> Ceiling - Grime - Small / (R) Front Trim - Grime - Small / (L) Front Trim - Grime - Small / (L) Front Floor Mat - Worked - Small</p>	<p><b>Remarks</b> (L) Rear Fender, Molding - Scratch - Small / (L) Rear Door, Molding - Scratch - Small / (L) Front Door, Molding - Scratch - Minimal / (L) Mirror - Scratch - Minimal / (L) Front Fender, Molding - Dent - Small / Front Bumper, Grille, Lamps - Scratch - Medium / Bonnet, Headlight - Scratch - Small / (R) Front Fender, Molding - Scratch - Small / (R) Front Door, Molding - Scratch - Minimal / (R) Rear Door, Molding - Scratch - Small / (R) Rear Fender, Molding - Scratch - Minimal / Rear Bumper, Lamps, Panels - Scratch &amp; Dent - Medium / Trunk Hood, Rear Gate - Scratch - Small</p>
