General Information

Make	Toyota	Model	Vios
YOM	2023	Odo Meter Reading	17,683
Registration No.	GBA2405	Chassis No.	PA1B18F33P4224697
CC	1.3	Transmission	CVT
Fuel Type	Gas	Type of Body	Sedan
Colour	Black

Body / Panel Condition

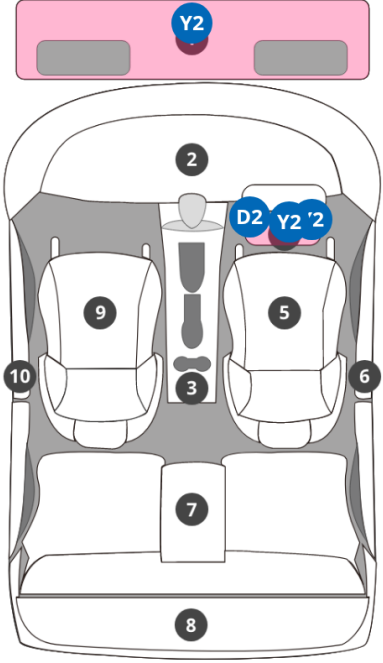
Interior Evaluation : A	Exterior Evaluation : C

<p>a : Cut, Fray d : Loose, Deformed k : Animal Hair s : Smell t : Cigarette Burns x : Defective y : Stain</p>

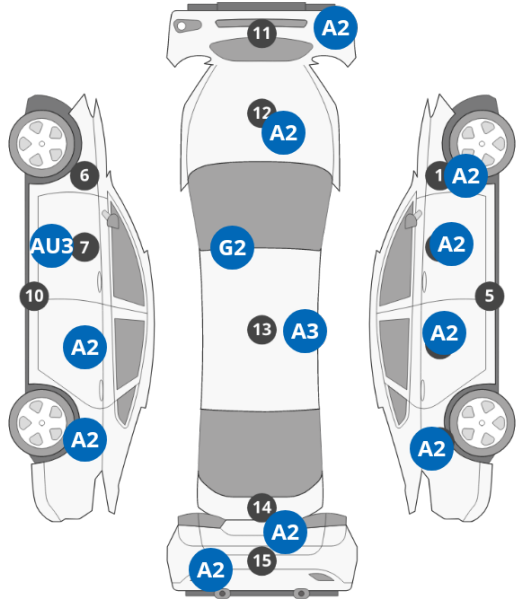
<p>A : Scratch AU : Scratch & Dent B : Modified C : Corrosion G : Stone chip P : Faded S : Rust SC : Rust & Corrosion U : Dent X : Defective Y : Crack, Gap</p>
<p>Remarks Ceiling - Grime - Small / (R) Front Floor Mat - Grime - Small / Mat Other - Grime - Small / (L) Front Floor Mat - Worked - Small</p>	<p>Remarks (R) Front Door, Molding - Scratch - Small / (R) Rear Door, Molding - Scratch - Small / (R) Rear Fender, Molding - Scratch - Small / Trunk Hood, Rear Gate - Scratch - Small / Rear Bumper, Lamps, Panels - Scratch - Small / (L) Rear Fender, Molding - Scratch - Small / (L) Rear Door, Molding - Scratch - Small / (L) Front Door, Molding - Scratch & Dent - Medium / Front Bumper, Grille, Lamps - Scratch - Small / (R) Front Fender, Molding - Scratch - Small / Bonnet, Headlight - Scratch - Small / Roof - Scratch - Medium / Front Windshield - Scratch, Stone chip - Small</p>
