General Information

Make	Toyota	Model	Vios
YOM	2024	Odo Meter Reading	28,673
Registration No.	GBC3023	Chassis No.	PA1B18F31P4232782
CC	1.3	Transmission	CVT
Fuel Type	Gas	Type of Body	Sedan
Colour	Blue

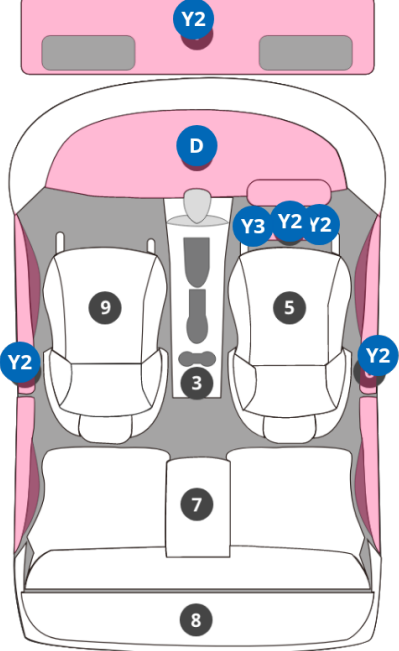
Interior Evaluation : B	Exterior Evaluation : C

<p>a : Cut, Fray d : Loose, Deformed k : Animal Hair s : Smell t : Cigarette Burns x : Defective y : Stain</p>

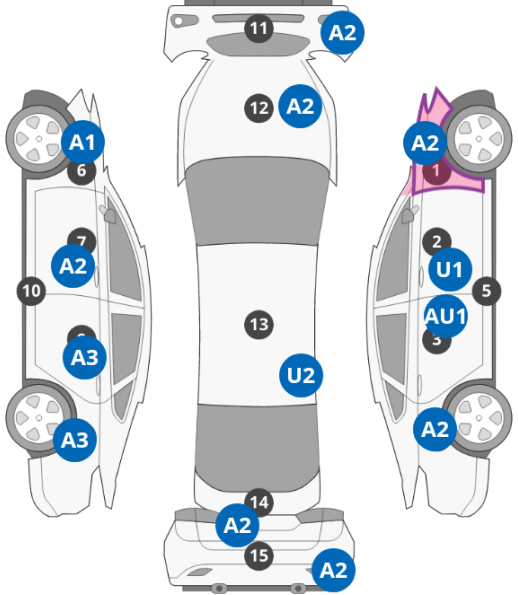
<p>A : Scratch AU : Scratch & Dent B : Modified C : Corrosion G : Stone chip P : Faded S : Rust SC : Rust & Corrosion U : Dent X : Defective Y : Crack, Gap</p>
<p>Remarks Ceiling - Grime - Small / (R) Front Trim - Grime - Small / (R) Front Floor Mat - Grime - Small / Dashboard - Traces of Adhesive Tape - Yes / Mat Other - Grime - Small / (L) Front Trim - Grime - Small / (L) Front Floor Mat - Grime - Medium</p>	<p>Remarks Bonnet, Headlight - Scratch - Small / (R) Front Fender, Molding - Scratch - Small / (R) Rear Door, Molding - Scratch & Dent - Minimal / (R) Front Door, Molding - Dent - Minimal / (R) Rear Fender, Molding - Scratch - Small / Rear Bumper, Lamps, Panels - Scratch - Small / (L) Rear Fender, Molding - Scratch - Medium / (L) Rear Door, Molding - Scratch - Medium / (L) Front Door, Molding - Scratch - Small / (L) Front Fender, Molding - Scratch - Minimal / Front Bumper, Grille, Lamps - Scratch - Small / Roof - Dent - Small / Trunk Hood, Rear Gate - Scratch - Small / (R) Front Wheel, Cover - Cap Missing - Yes</p>
