## General Information

<b>Make</b>	Toyota	<b>Model</b>	Vios
<b>YOM</b>	2024	<b>Odo Meter Reading</b>	6,490
<b>Registration No.</b>	GBC1104	<b>Chassis No.</b>	PA1B18F31P4232894
<b>CC</b>	1.3	<b>Transmission</b>	CVT
<b>Fuel Type</b>	Gas	<b>Type of Body</b>	Sedan
<b>Colour</b>	Red Mica Metallic

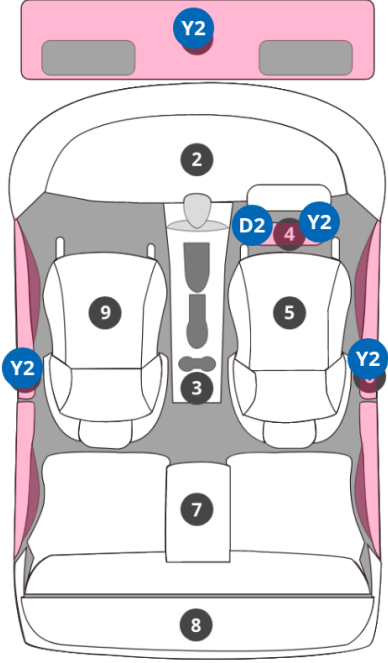
<b>Interior Evaluation :</b> <span style="float: right; color: red; font-weight: bold;">B</span>	<b>Exterior Evaluation :</b> <span style="float: right; color: red; font-weight: bold;">E</span>

<p><b>a</b> : Cut, Fray <b>d</b> : Loose, Deformed <b>k</b> : Animal Hair <b>s</b> : Smell <b>t</b> : Cigarette Burns <b>x</b> : Defective <b>y</b> : Stain</p>

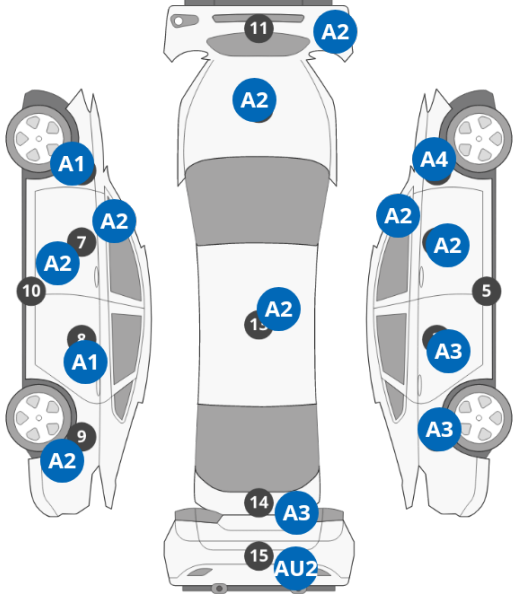
<p><b>A</b> : Scratch <b>AU</b> : Scratch &amp; Dent <b>B</b> : Modified <b>C</b> : Corrosion <b>G</b> : Stone chip <b>P</b> : Faded <b>S</b> : Rust <b>SC</b> : Rust &amp; Corrosion <b>U</b> : Dent <b>X</b> : Defective <b>Y</b> : Crack, Gap</p>
<p><b>Remarks</b> Ceiling - Grime - Small / (R) Front Trim - Grime - Small / (R) Front Floor Mat - Grime - Small / (L) Front Trim - Grime - Small / (L) Front Floor Mat - Worked - Small</p>	<p><b>Remarks</b> (R) Rear Door, Molding - Scratch - Medium / (R) Front Door, Molding - Scratch - Small / (R) Mirror - Scratch - Small / (R) Front Fender, Molding - Scratch - Large / (R) Rear Fender, Molding - Scratch - Medium / Trunk Hood, Rear Gate - Scratch - Medium / Rear Bumper, Lamps, Panels - Scratch &amp; Dent - Small / (L) Rear Fender, Molding - Scratch - Small / (L) Mirror - Scratch - Small / (L) Front Door, Molding - Scratch - Small / (L) Rear Door, Molding - Scratch - Minimal / (L) Front Fender, Molding - Scratch - Minimal / Bonnet, Headlight - Scratch - Small / Front Bumper, Grille, Lamps - Scratch - Small / Roof - Scratch - Small</p>

<p><b>Inspector Notes</b></p>
<p>Scratches on headlight and taillight. Without warranty booklet and tools. With spare tire,jack and seat cover. 1 key. No LTO plate.</p>
