## General Information

<b>Make</b>	Toyota	<b>Model</b>	Vios
<b>YOM</b>	2025	<b>Odo Meter Reading</b>	54,487
<b>Registration No.</b>	GBJ8046	<b>Chassis No.</b>	PA1B18F36S4283803
<b>CC</b>	1.3	<b>Transmission</b>	CVT
<b>Fuel Type</b>	Gas	<b>Type of Body</b>	Sedan
<b>Colour</b>	Red

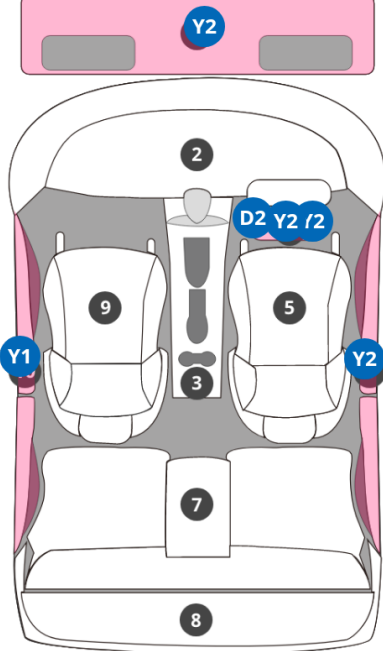
<b>Interior Evaluation :</b> <span style="float: right;"><b>B</b></span>	<b>Exterior Evaluation :</b> <span style="float: right;"><b>B</b></span>

<p><b>a</b> : Cut, Fray <b>d</b> : Loose, Deformed <b>k</b> : Animal Hair <b>s</b> : Smell <b>t</b> : Cigarette Burns <b>x</b> : Defective <b>y</b> : Stain</p>

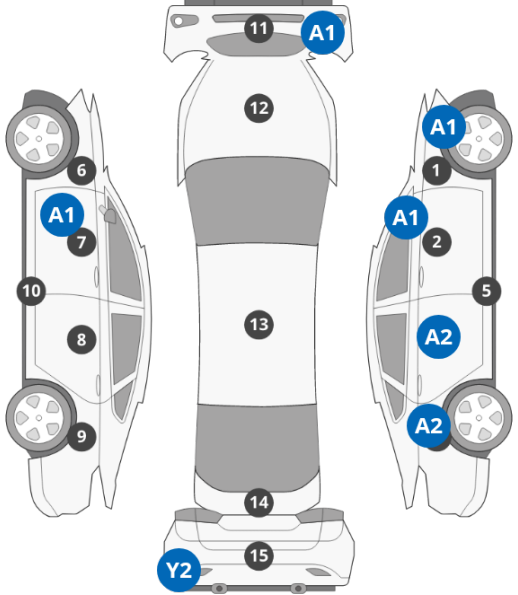
<p><b>A</b> : Scratch <b>AU</b> : Scratch &amp; Dent <b>B</b> : Modified <b>C</b> : Corrosion <b>G</b> : Stone chip <b>P</b> : Faded <b>S</b> : Rust <b>SC</b> : Rust &amp; Corrosion <b>U</b> : Dent <b>X</b> : Defective <b>Y</b> : Crack, Gap</p>
<p><b>Remarks</b> Ceiling - Grime - Small / (R) Front Floor Mat - Grime - Small / (R) Front Trim - Grime - Small / Mat Other - Grime - Small / (L) Front Trim - Grime - Minimal / (L) Front Floor Mat - Worked - Small</p>	<p><b>Remarks</b> Front Bumper, Grille, Lamps - Scratch - Minimal / (R) Front Fender, Molding - Scratch - Minimal / (R) Mirror - Scratch - Minimal / (R) Rear Fender, Molding - Scratch - Small / (R) Rear Door, Molding - Scratch - Small / Rear Bumper, Lamps, Panels - Crack, Gap - Small / (L) Front Door, Molding - Scratch - Minimal</p>
