## General Information

| Make | Mitsubishi | Model | Mirage |

## Body / Panel Condition

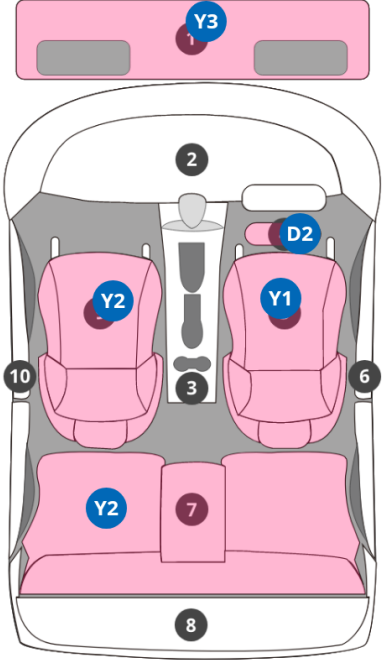
| Interior Evaluation : <b>B</b> | Exterior Evaluation : <b>B</b> |
|---|---|
| <p><b>Remarks</b><br/>Ceiling - Grime - Medium / (L) Front Floor Mat - Worked - Small / (R) Front Seat - Grime - Minimal / (L) Front Seat - Grime - Small / Rear Seat - Grime - Small</p> | <p><b>Remarks</b><br/>Rear Bumper, Lamps, Panels - Crack, Gap - Medium / (R) Front Door, Molding - Dent - Small / (L) Rear Fender, Molding - Scratch - Minimal / Front Bumper, Grille, Lamps - Scratch &amp; Dent - Small / (R) Front Fender, Molding - Scratch - Minimal / Bonnet, Headlight - Scratch - Small / (L) Mirror - Scratch - Minimal / Roof - Scratch &amp; Dent - Minimal</p> |
