General Information

Make	Mitsubishi	Model	Xpander
YOM	2025	Odo Meter Reading	10,894
Registration No.	NKC9779	Chassis No.	MK2LRNC1WSN00347
CC	1.5	Transmission	A/T
Fuel Type	Gas	Type of Body	Wagon
Colour	Gray

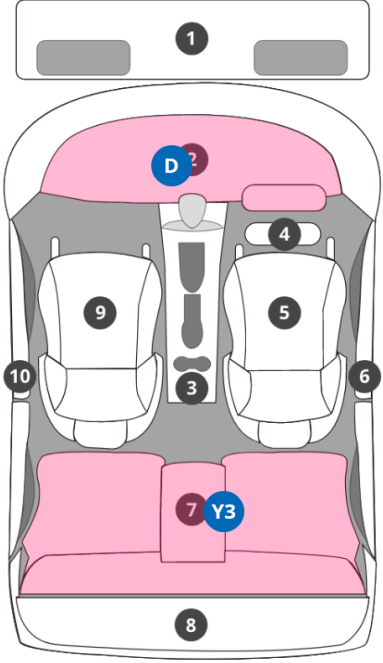
Interior Evaluation : B	Exterior Evaluation : E

<p>a : Cut, Fray d : Loose, Deformed k : Animal Hair s : Smell t : Cigarette Burns x : Defective y : Stain</p>

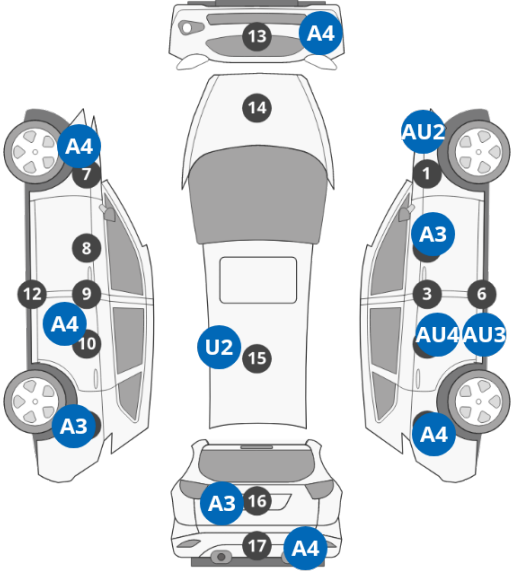
<p>A : Scratch AU : Scratch & Dent B : Modified C : Corrosion G : Stone chip P : Faded S : Rust SC : Rust & Corrosion U : Dent X : Defective Y : Crack, Gap</p>
Remarks Rear Seat - Grime - Medium / Dashboard - Traces of Adhesive Tape - Yes	Remarks (L) Front Fender, Molding - Scratch - Large / (L) Rear Door, Molding - Scratch - Large / (L) Rear Fender, Molding - Scratch - Medium / Trunk Hood, Rear Gate - Scratch - Medium / Rear Bumper, Lamps, Panels - Scratch - Large / (R) Rear Fender, Molding - Scratch - Large / (R) Rear Door, Molding - Scratch & Dent - Large / (R) Step, In-panel, Side Spoiler - Scratch & Dent - Medium / (R) Front Door, Molding - Scratch - Medium / Front Bumper, Grille, Lamps - Scratch - Large / (R) Front Fender, Molding - Scratch & Dent - Small / Roof - Dent - Small
