## General Information

| Make | Toyota | Model | Vios |
| YOM | 2019 | Odo Meter Reading | 41,573 |
| Registration No. | NBT1028 | Chassis No. | PA1B13F37K4079627 |

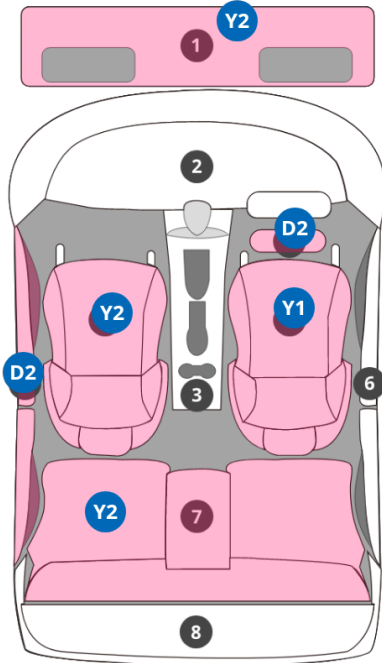
| Interior Evaluation : <b>B</b> | Exterior Evaluation : <b>D</b> |
|---|---|
| <p><b>Remarks</b><br/>Rear Seat - Grime - Small / (L) Front Floor Mat - Worked - Small / Ceiling - Grime - Small / (R) Front Seat - Grime - Minimal / (L) Front Seat - Grime - Small / (L) Front Trim - Worked - Small</p> | <p><b>Remarks</b><br/>(R) Front Door - Repair Traces - Yes / (R) Front Door, Molding - Repair mark - Yes / (R) Rear Door, Molding - Scratch - Small / (R) Rear Fender, Molding - Scratch &amp; Dent - Small / (R) Front Door, Molding - Scratch - Small / Front Bumper, Grille, Lamps - Scratch - Large / (R) Front Fender, Molding - Scratch - Small / (R) Mirror - Scratch - Minimal / Member (Bolted) - Dent - Yes / Bonnet, Headlight - Scratch - Small / (L) Front Fender, Molding - Scratch - Small / (L) Front Door, Molding - Scratch - Minimal / (L) Step, In-panel, Side Spoiler - Scratch &amp; Dent - Small / (L) Rear Door, Molding - Scratch - Minimal / (L) Rear Fender, Molding - Scratch &amp; Dent - Small / Roof - Scratch &amp; Dent - Small / Trunk Hood, Rear Gate - Scratch &amp; Dent - Minimal / Rear Bumper, Lamps, Panels - Scratch - Small</p> |
