## General Information

| Make | Toyota | Model | Lite Ace |

## Body / Panel Condition

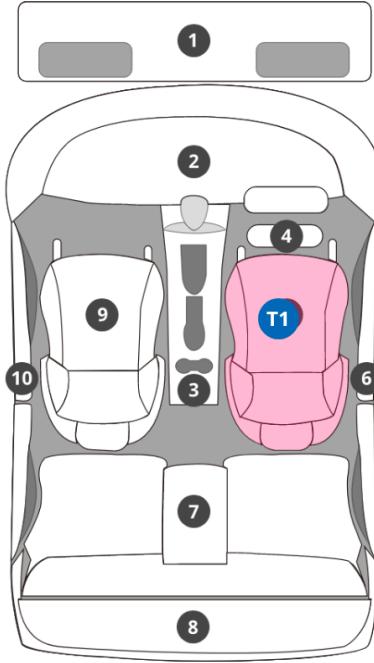
| Interior Evaluation : <span style="color: red;">C</span> | Exterior Evaluation : <span style="color: red;">E</span> |
| <p><b>Remarks</b></p> <p>(R) Front Seat - Cigarette Burns - Burnt Minimal / Overall Interior - Worn as per age - Yes</p> | <p><b>Remarks</b></p> <p>(L) Front Fender, Molding - Scratch &amp; Dent - Large / Bonnet, Headlight - Scratch &amp; Dent - Medium / (L) Front Door, Molding - Crack, Gap - Large / (L) Side Gate - Scratch &amp; Dent - Large / Rear Bumper, Lamps, Panels - Rust, Corrosion - Large / Cargo Bed Floor - Scratch &amp; Dent - Large / Rear Gate - Scratch - Large / (R) Side Gate - Scratch &amp; Dent - Large / (R) Front Door, Molding - Scratch - Large / (R) Front Fender, Molding - Scratch &amp; Dent - Medium / Front Bumper, Grille, Lamps - Scratch &amp; Dent - Large</p> |
