## General Information

| Make | Toyota | Model | Wigo |

## Body / Panel Condition

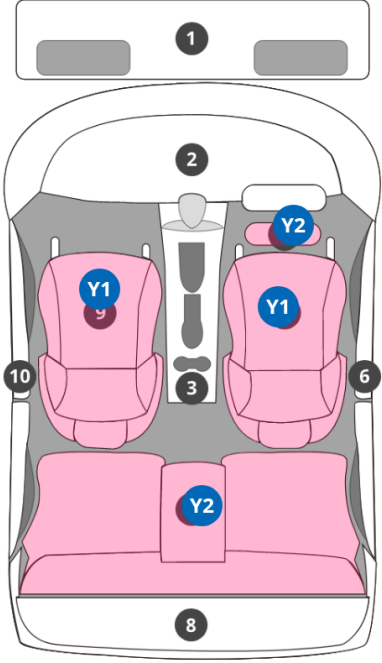
| Interior Evaluation : <span style="color: red; font-weight: bold;">A</span> | Exterior Evaluation : <span style="color: red; font-weight: bold;">C</span> |
| <b>Remarks</b><br>(R) Front Seat - Grime - Minimal / Rear Seat - Grime - Small / (L) Front Floor Mat - Grime - Small / (L) Front Seat - Grime - Minimal | <b>Remarks</b><br>Front Bumper, Grille, Lamps - Scratch & Dent - Medium / (R) Front Door, Molding - Dent - Minimal / (R) Rear Fender, Molding - Scratch & Dent - Small / (L) Rear Fender, Molding - Scratch - Minimal / (R) Mirror - Scratch - Minimal / (R) Front Fender, Molding - Scratch - Minimal / Bonnet, Headlight - Scratch - Small / (L) Front Fender, Molding - Scratch - Small / (L) Front Door, Molding - Scratch - Small / (L) Rear Door, Molding - Scratch - Small / (R) Rear Door, Molding - Scratch - Small |
