## General Information

| Make | Toyota | Model | Vios |
| YOM | 2024 | Odo Meter Reading | 21,873 |
| Registration No. | DBO6547 | Chassis No. | PA1B18F31R4256874 |

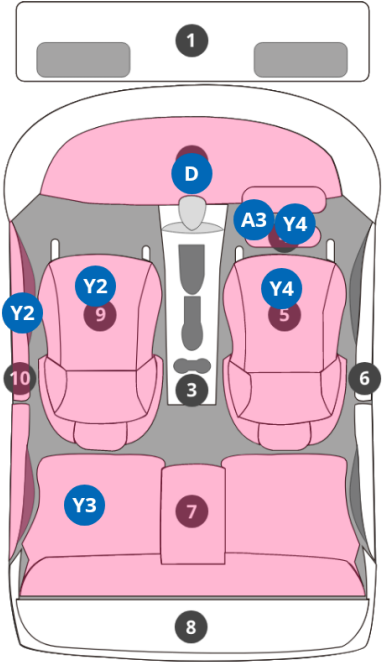
| Interior Evaluation : <span style="color: red; font-weight: bold;">C</span> | Exterior Evaluation : <span style="color: red; font-weight: bold;">E</span> |
|---|---|
| <b>Remarks</b><br>(L) Front Seat - Grime - Small / (L) Front Trim - Grime - Small / (L) Front Floor Mat - Cut, Crack - Medium / Dashboard - Traces of Adhesive Tape - Yes / (R) Front Seat - Grime - Large / Rear Seat - Grime - Medium / (R) Front Floor Mat - Grime - Large | <b>Remarks</b><br>(L) Front Door - Repair Traces - Yes / (L) Step - Repair Traces - Yes / (L) Rear Door - Repair Traces - Yes / (L) Rear Door, Molding - Repair mark - Yes / (L) Rear Door, Molding - Scratch & Dent - Large / (L) Rear Fender, Molding - Scratch & Dent - Medium / (L) Front Door, Molding - Scratch & Dent - Small / (L) Front Fender, Molding - Dent - Medium / Bonnet, Headlight - Dent - Medium / Front Bumper, Grille, Lamps - Scratch & Dent - Large / (R) Front Door, Molding - Scratch - Large / (R) Step, In-panel, Side Spoiler - Scratch - Small / (R) Rear Door, Molding - Scratch - Small / (R) Rear Fender, Molding - Repair mark - Yes / (L) Rear Fender, Molding - Repair mark - Yes / Trunk Hood, Rear Gate - Scratch & Dent - Small / Roof - Repair mark - Yes |
