## General Information

| Make | Suzuki | Model | S-Presso |
| YOM | 2024 | Odo Meter Reading | 8,350 |
| Registration No. | NKA5553 | Chassis No. | MA3FL61S6RA481512 |

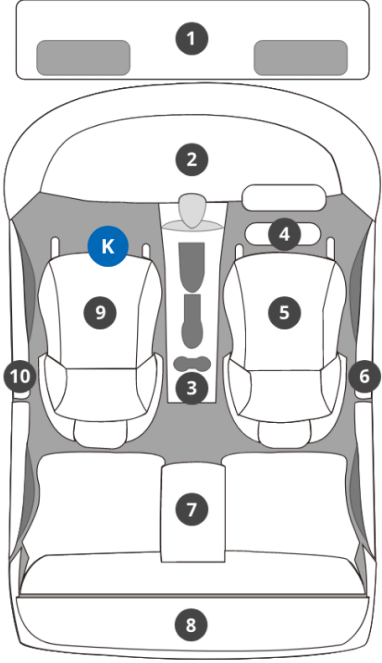
| Interior Evaluation : <b>B</b> | Exterior Evaluation : <b>D</b> |
| <b>Remarks</b><br>Overall Interior - Animal Hair - Yes | <b>Remarks</b><br>Rear Bumper, Lamps, Panels - Scratch - Large / (R) Rear Fender, Molding - Scratch - Medium / Front Bumper, Grille, Lamps - Scratch & Dent - Large / (R) Front Door, Molding - Scratch & Dent - Small / (L) Front Fender, Molding - Crack, Gap - Medium / (L) Front Door, Molding - Crack, Gap - Small / Trunk Hood, Rear Gate - Scratch - Small / (L) Rear Door, Molding - Scratch - Small / (L) Rear Fender, Molding - Scratch - Small / (R) Rear Door, Molding - Scratch - Small / (R) Front Fender, Molding - Scratch - Small |
