General Information

Make	Toyota	Model	Vios
YOM	2024	Odo Meter Reading	3,533
Registration No.	BAF7476	Chassis No.	PA1B18F38P4234075
CC	1.3	Transmission	CVT
Fuel Type	Gas	Type of Body	Sedan
Colour	Blue

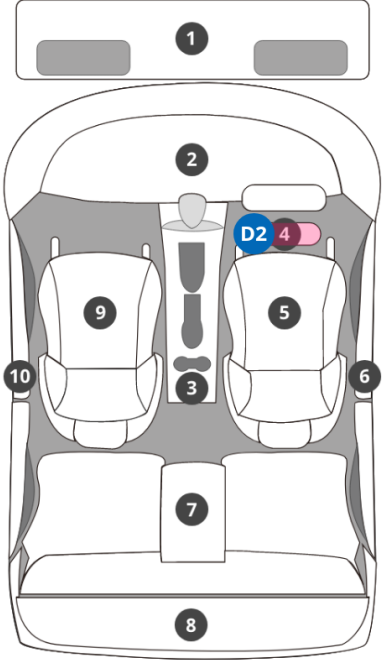
Interior Evaluation : A	Exterior Evaluation : C

<p>a : Cut, Fray d : Loose, Deformed k : Animal Hair s : Smell t : Cigarette Burns x : Defective y : Stain</p>

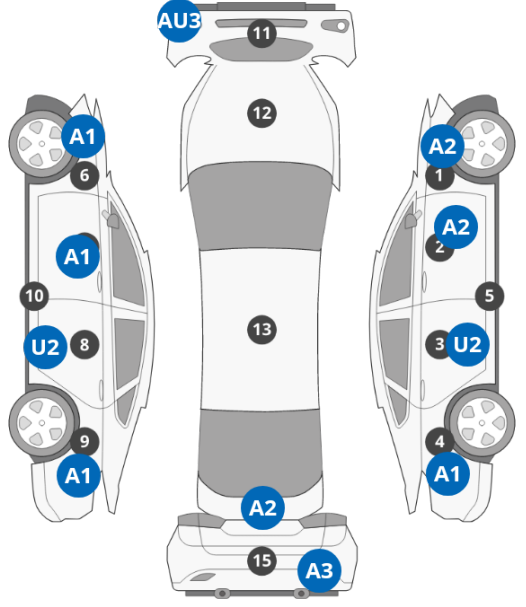
<p>A : Scratch AU : Scratch & Dent B : Modified C : Corrosion G : Stone chip P : Faded S : Rust SC : Rust & Corrosion U : Dent X : Defective Y : Crack, Gap</p>
Remarks (L) Front Floor Mat - Worked - Small	Remarks Rear Bumper, Lamps, Panels - Scratch - Medium / Front Bumper, Grille, Lamps - Scratch & Dent - Medium / (L) Rear Door, Molding - Dent - Small / (L) Front Door, Molding - Scratch - Minimal / (L) Front Fender, Molding - Scratch - Minimal / (L) Rear Fender, Molding - Scratch - Minimal / (R) Rear Door, Molding - Dent - Small / (R) Front Door, Molding - Scratch - Small / (R) Rear Fender, Molding - Scratch - Minimal / (R) Front Fender, Molding - Scratch - Small / Trunk Hood, Rear Gate - Scratch - Small
Frame Evaluation : A	Functional Evaluation : B
