General Information

Make	Toyota	Model	Vios
YOM	2022	Odo Meter Reading	31,717
Registration No.	NFI5194	Chassis No.	PA1B18F32M4162446
CC	1.3	Transmission	CVT
Fuel Type	Gas	Type of Body	Sedan
Colour	Blue

Body / Panel Condition

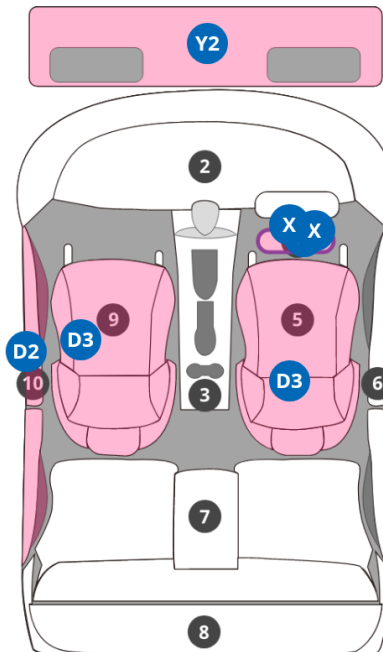
Interior Evaluation : B	Exterior Evaluation : C

<p>a : Cut, Fray d : Loose, Deformed k : Animal Hair s : Smell t : Cigarette Burns x : Defective y : Stain</p>

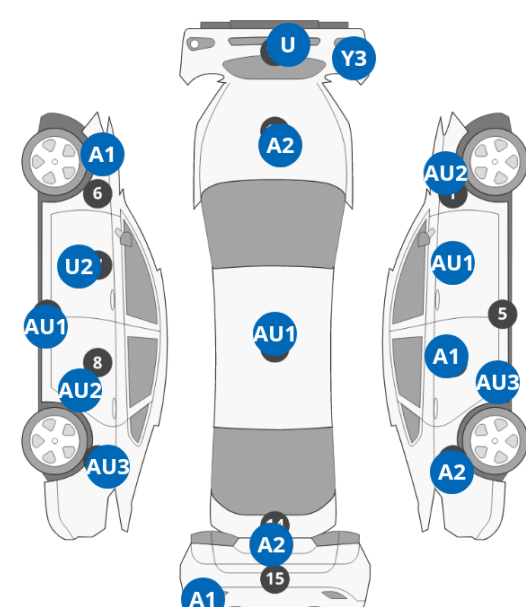
<p>A : Scratch AU : Scratch & Dent B : Modified C : Corrosion G : Stone chip P : Faded S : Rust SC : Rust & Corrosion U : Dent X : Defective Y : Crack, Gap</p>
<p>Remarks Mat Other - Missing - Yes / (L) Front Floor Mat - Missing - Yes / (R) Front Floor Mat - Missing - Yes / Ceiling - Grime - Small / (L) Front Seat belt - Loose, Deformed - Medium / (R) Front Seat belt - Loose, Deformed - Medium / (L) Front Trim - Worked - Small</p>	<p>Remarks (L) Rear Fender, Molding - Scratch & Dent - Medium / (L) Rear Door, Molding - Scratch & Dent - Small / (L) Front Door, Molding - Dent - Small / (L) Step, In-panel, Side Spoiler - Scratch & Dent - Minimal / Member (Bolted) - Dent - Yes / (R) Step, In-panel, Side Spoiler - Scratch & Dent - Medium / (R) Rear Fender, Molding - Scratch - Small / (R) Front Fender, Molding - Scratch & Dent - Small / Front Bumper, Grille, Lamps - Crack, Gap - Medium / Bonnet, Headlight - Scratch - Small / (L) Front Fender, Molding - Scratch - Minimal / Roof - Scratch & Dent - Minimal / (R) Rear Door, Molding - Scratch - Minimal / (R) Front Door, Molding - Scratch & Dent - Minimal / Trunk Hood, Rear Gate - Scratch - Small / Rear Bumper, Lamps, Panels - Scratch - Minimal</p>
