General Information

Make	Toyota	Model	Rush
YOM	2019	Odo Meter Reading	46,533
Registration No.	EAD4962	Chassis No.	MHKE8FF3PKK014429
CC	1.5	Transmission	A/T
Fuel Type	Gas	Type of Body	SUV
Colour	Red

Body / Panel Condition

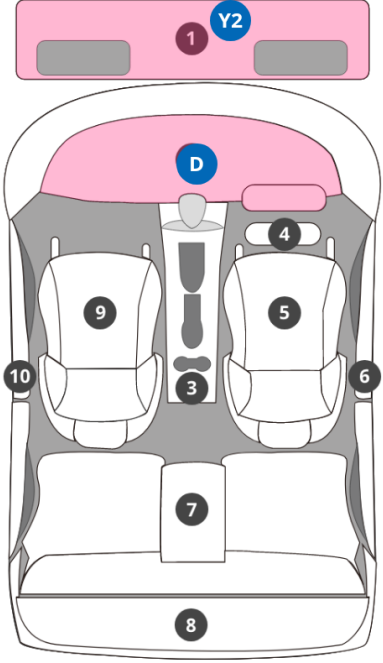
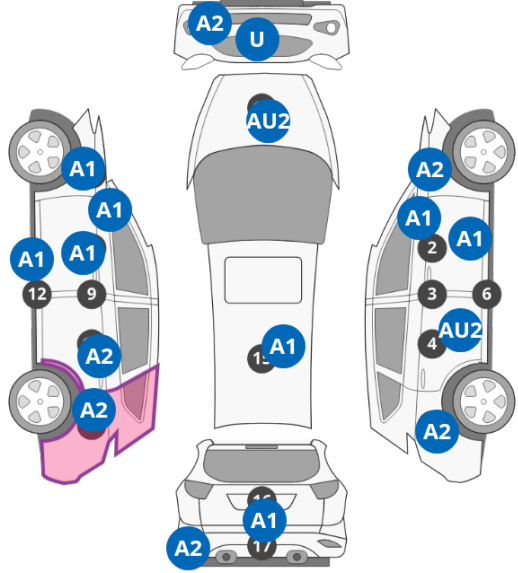
Interior Evaluation :	A	Exterior Evaluation :	C

<p>a : Cut, Fray d : Loose, Deformed k : Animal Hair s : Smell t : Cigarette Burns x : Defective y : Stain</p>		<p>A : Scratch AU : Scratch & Dent B : Modified C : Corrosion G : Stone chip P : Faded S : Rust SC : Rust & Corrosion U : Dent X : Defective Y : Crack, Gap</p>	
<p>Remarks Ceiling - Grime - Small / Dashboard - Traces of Adhesive Tape - Yes</p>		<p>Remarks (L) Rear Fender - Repair Traces - Yes / (L) Rear Door, Molding - Scratch - Small / (L) Mirror - Scratch - Minimal / (L) Rear Fender, Molding - Repair mark - Yes / (L) Front Door, Molding - Scratch - Minimal / (L) Step, In-panel, Side Spoiler - Scratch - Minimal / Member (Bolted) - Dent - Yes / Front Bumper, Grille, Lamps - Scratch - Small / Bonnet, Headlight - Scratch & Dent - Small / (R) Front Fender, Molding - Scratch - Small / (L) Front Fender, Molding - Scratch - Minimal / (R) Mirror - Scratch - Minimal / (R) Front Door, Molding - Scratch - Minimal / (R) Rear Door, Molding - Scratch & Dent - Small / (R) Rear Fender, Molding - Scratch - Small / Trunk Hood, Rear Gate - Scratch - Minimal / Rear Bumper, Lamps, Panels - Scratch - Small / (L) Rear Fender, Molding - Scratch - Small / Roof - Scratch - Minimal</p>

With LTO plate and Spare tire and Warranty booklet, No Tools and Jack, No Spare key, Scratch headlight and tail light, Worn Tires, foul smell, Abnormal noise on door when it open.
