General Information

Make	Hyundai	Model	Reina
YOM	2019	Odo Meter Reading	89,075
Registration No.	FAG1726	Chassis No.	LBECBACB2LW082516
CC	1.4	Transmission	M/T
Fuel Type	Gas	Type of Body	Sedan
Colour	Silver

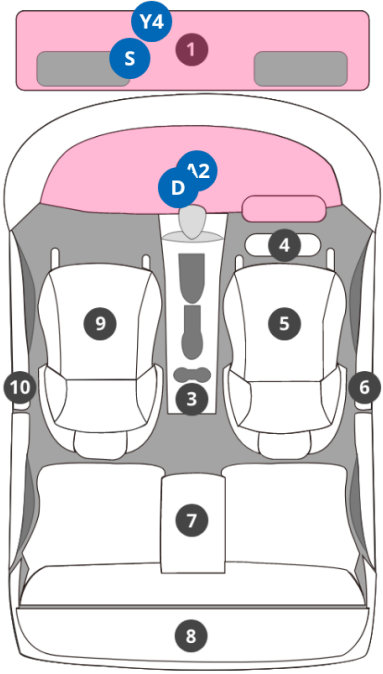
Interior Evaluation : C	Exterior Evaluation : C

<p>a : Cut, Fray d : Loose, Deformed k : Animal Hair s : Smell t : Cigarette Burns x : Defective y : Stain</p>

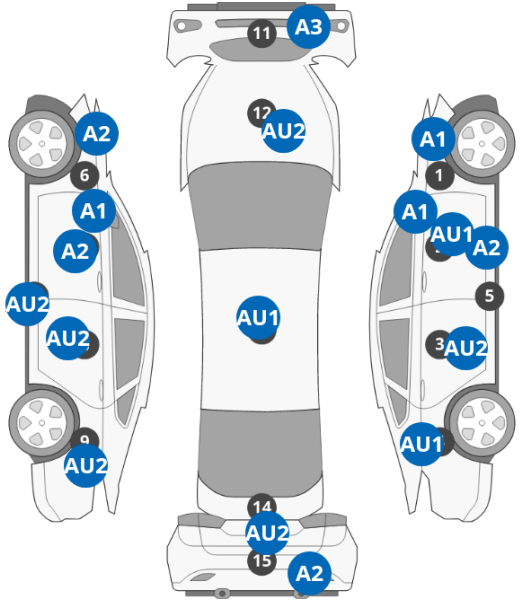
<p>A : Scratch AU : Scratch & Dent B : Modified C : Corrosion G : Stone chip P : Faded S : Rust SC : Rust & Corrosion U : Dent X : Defective Y : Crack, Gap</p>
<p>Remarks Ceiling - Grime - Large / Overall Interior - Smell - Yes / Dashboard - Worn, Scratch, Cut, Crack - Small / Dashboard - Traces of Adhesive Tape - Yes</p>	<p>Remarks Front Bumper, Grille, Lamps - Scratch - Medium / Bonnet, Headlight - Scratch & Dent - Small / (R) Step, In-panel, Side Spoiler - Scratch - Small / (R) Front Door, Molding - Scratch & Dent - Minimal / (R) Rear Door, Molding - Scratch & Dent - Small / (R) Rear Fender, Molding - Scratch & Dent - Minimal / Trunk Hood, Rear Gate - Scratch & Dent - Small / Rear Bumper, Lamps, Panels - Scratch - Small / (L) Rear Fender, Molding - Scratch & Dent - Small / (L) Rear Door, Molding - Scratch & Dent - Small / (L) Front Door, Molding - Scratch - Small / (L) Step, In-panel, Side Spoiler - Scratch & Dent - Small / (L) Front Fender, Molding - Scratch - Small / (R) Front Fender, Molding - Scratch - Minimal / (R) Mirror - Scratch - Minimal / (L) Mirror - Scratch - Minimal / Roof - Scratch & Dent - Minimal</p>
