General Information

Make	Toyota	Model	Vios
YOM	2024	Odo Meter Reading	9,721
Registration No.	NFF6477	Chassis No.	PA1B18F33P4234730
CC	1.3	Transmission	CVT
Fuel Type	Gas	Type of Body	Sedan
Colour	Black

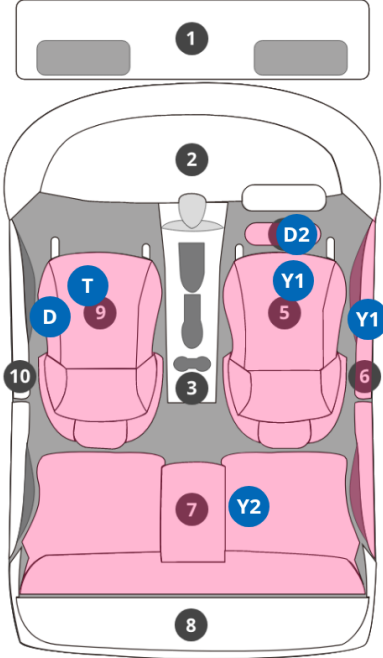
Interior Evaluation : C	Exterior Evaluation : B

<p>a : Cut, Fray d : Loose, Deformed k : Animal Hair s : Smell t : Cigarette Burns x : Defective y : Stain</p>

<p>A : Scratch AU : Scratch & Dent B : Modified C : Corrosion G : Stone chip P : Faded S : Rust SC : Rust & Corrosion U : Dent X : Defective Y : Crack, Gap</p>
<p>Remarks (L) Front Seat - Cigarette Burns - Burnt, Hole / Rear Seat - Grime - Small / (L) Front Seat - Worn - Yes / (R) Front Seat - Grime - Minimal / (L) Front Floor Mat - Worked - Small / (R) Front Trim - Grime - Minimal</p>	<p>Remarks (R) Front Fender, Molding - Scratch - Minimal / (R) Mirror - Scratch - Minimal / (R) Front Door, Molding - Scratch - Small / (R) Rear Door, Molding - Scratch - Small / (R) Rear Fender, Molding - Scratch - Minimal / Rear Bumper, Lamps, Panels - Scratch & Dent - Small / Trunk Hood, Rear Gate - Scratch - Minimal / (L) Rear Fender, Molding - Scratch - Small / (L) Rear Door, Molding - Scratch - Small / (L) Front Door, Molding - Scratch - Minimal / (L) Mirror - Scratch - Minimal / (L) Front Fender, Molding - Scratch - Minimal / Front Bumper, Grille, Lamps - Scratch - Small / Bonnet, Headlight - Scratch - Minimal / Roof - Scratch - Minimal</p>

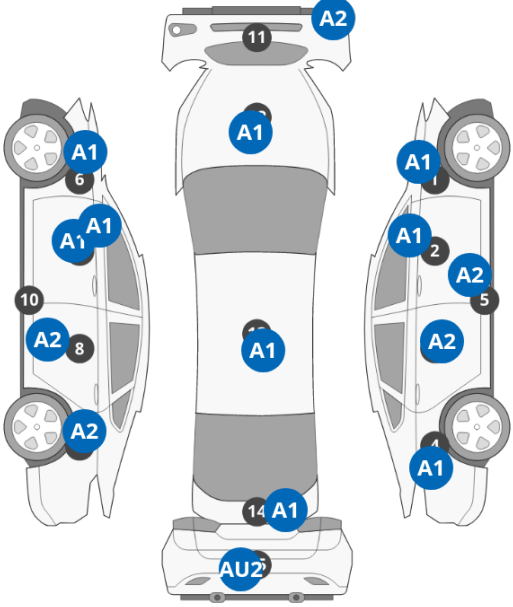
<p>Inspector Notes</p>
<p>with warranty booklet, with jack, incomplete tools, with spare tire, no LTO plate, scratches on tail light</p>
