General Information

Make	Hyundai	Model	Eon
YOM	2015	Odo Meter Reading	76,604
Registration No.	NDR8543	Chassis No.	MALA351AAF350006
CC	0.8	Transmission	M/T
Fuel Type	Gas	Type of Body	Hatchback
Colour	White

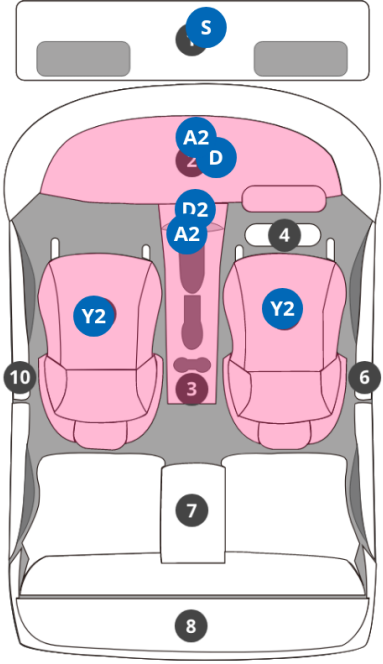
Interior Evaluation : C	Exterior Evaluation : E

<p>a : Cut, Fray d : Loose, Deformed k : Animal Hair s : Smell t : Cigarette Burns x : Defective y : Stain</p>

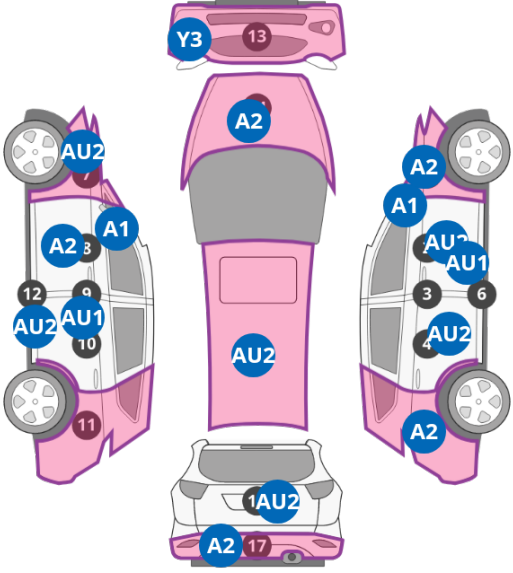
<p>A : Scratch AU : Scratch & Dent B : Modified C : Corrosion G : Stone chip P : Faded S : Rust SC : Rust & Corrosion U : Dent X : Defective Y : Crack, Gap</p>
<p>Remarks Overall Interior - Smell - Yes / Overall Interior - Worn as per age - Yes / Dashboard - Traces of Adhesive Tape - Yes / Dashboard - Worn, Scratch, Cut, Crack - Small / Console, Switches, Vents - Loose, Deformed - Small / Knobs - Worn, Peel, Crack - Small / (R) Front Seat - Grime - Small / (L) Front Seat - Grime - Small</p>	<p>Remarks (R) Front Door - Repair Traces - Yes / Bonnet - Repair Traces - Yes / (L) Front Fender - Repair Traces - Yes / (L) Rear Fender - Repair Traces - Yes / (R) Rear Fender - Repair Traces - Yes / (L) Front Fender, Molding - Repair mark - Yes / (L) Rear Fender, Molding - Repair mark - Yes / (R) Rear Fender, Molding - Repair mark - Yes / Roof - Repair mark - Yes / (R) Front Fender, Molding - Repair mark - Yes / Bonnet, Headlight - Repair mark - Yes / Front Bumper, Grille, Lamps - Repair mark - Yes / Front Bumper, Grille, Lamps - Crack, Gap - Medium / Rear Bumper, Lamps, Panels - Repair mark - Yes / Rear Bumper, Lamps, Panels - Scratch - Small / Trunk Hood, Rear Gate - Scratch & Dent - Small / (R) Rear Fender, Molding - Scratch - Small / (R) Rear Door, Molding - Scratch & Dent - Small / (R) Front Door, Molding - Scratch & Dent - Small / (R) Front Fender, Molding - Scratch - Small / (R) Mirror - Scratch - Minimal / Bonnet, Headlight - Scratch - Small / Roof - Scratch & Dent - Small / (L) Mirror - Scratch - Minimal / (L) Front Fender, Molding - Scratch & Dent - Small / (L) Front Door, Molding - Scratch - Small / (L) Rear Door, Molding - Scratch & Dent - Minimal / (L) Step, In-panel, Side Spoiler - Scratch & Dent - Small / (R) Step, In-panel, Side Spoiler - Scratch & Dent - Minimal</p>
