General Information

Make	Geely	Model	Okavango
YOM	2022	Odo Meter Reading	32,058
Registration No.	NIH1899	Chassis No.	L6T7922Z8NY022625
CC	1.5	Transmission	A/T
Fuel Type	Gas	Type of Body	SUV
Colour	Gray

Body / Panel Condition

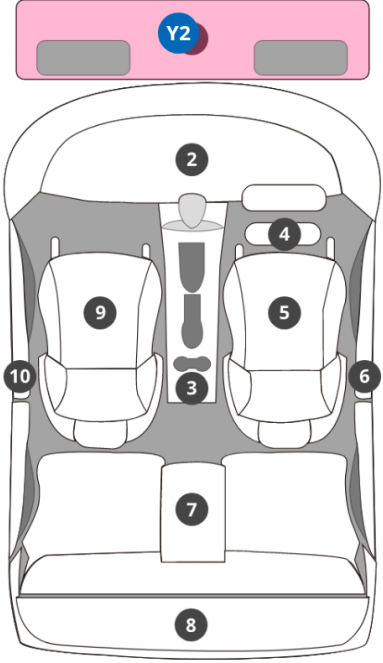
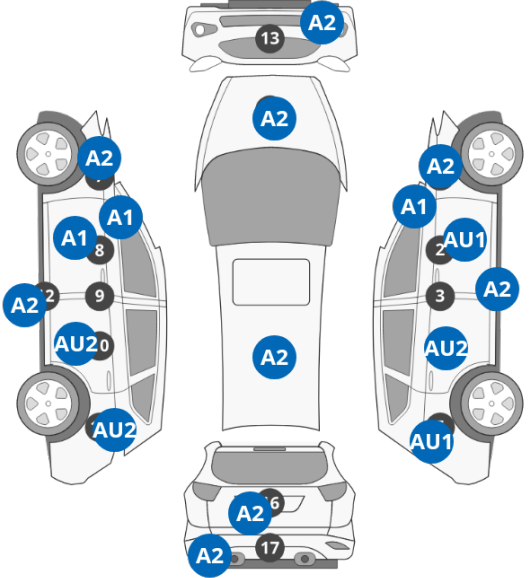
Interior Evaluation :	A	Exterior Evaluation :	C

<p>a : Cut, Fray d : Loose, Deformed k : Animal Hair s : Smell t : Cigarette Burns x : Defective y : Stain</p>		<p>A : Scratch AU : Scratch & Dent B : Modified C : Corrosion G : Stone chip P : Faded S : Rust SC : Rust & Corrosion U : Dent X : Defective Y : Crack, Gap</p>	
<p>Remarks Ceiling - Grime - Small</p>		<p>Remarks (L) Mirror - Scratch - Minimal / (L) Front Door, Molding - Scratch - Minimal / (L) Rear Door, Molding - Scratch & Dent - Small / (L) Rear Fender, Molding - Scratch & Dent - Small / (L) Step, In-panel, Side Spoiler - Scratch - Small / Front Bumper, Grille, Lamps - Scratch - Small / Bonnet, Headlight - Scratch - Small / (L) Front Fender, Molding - Scratch - Small / (R) Front Fender, Molding - Scratch - Small / (R) Front Door, Molding - Scratch & Dent - Minimal / (R) Rear Door, Molding - Scratch & Dent - Small / (R) Rear Fender, Molding - Scratch & Dent - Minimal / (R) Step, In-panel, Side Spoiler - Scratch - Small / (R) Mirror - Scratch - Minimal / Roof - Scratch - Small / Trunk Hood, Rear Gate - Scratch - Small / Rear Bumper, Lamps, Panels - Scratch - Small</p>

Inspector Notes
with LTO plate and Sparetire and Jack and Incomplete Tools, No warranty booklet and scratch headlight and tail light, no spare key. foul smel.l
