General Information

Make	Mitsubishi	Model	Adventure
YOM	2017	Odo Meter Reading	185,356
Registration No.	NAU7040	Chassis No.	PAEVB5NMHH008769
CC	2.5	Transmission	M/T
Fuel Type	Diesel	Type of Body	Wagon
Colour	Red

Body / Panel Condition

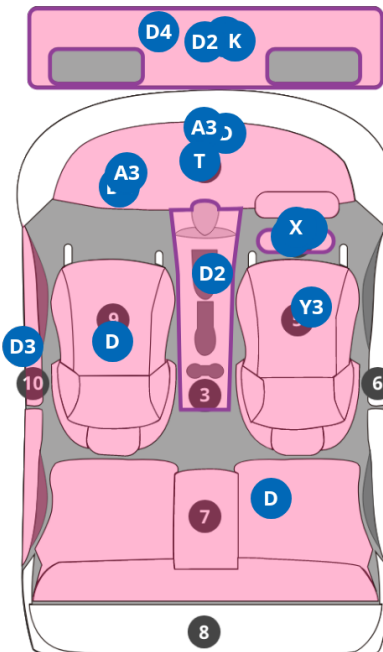
<p>Interior Evaluation : E</p>	<p>Exterior Evaluation : E</p>
<div style="text-align: center;">

</div> <p>a : Cut, Fray d : Loose, Deformed k : Animal Hair s : Smell t : Cigarette Burns x : Defective y : Stain</p>	<div style="text-align: center;">

</div> <p>A : Scratch AU : Scratch & Dent B : Modified C : Corrosion G : Stone chip P : Faded S : Rust SC : Rust & Corrosion U : Dent X : Defective Y : Crack, Gap</p>
<p>Remarks</p> <p>(L) Front Floor Mat - Missing - Yes / (R) Front Floor Mat - Missing - Yes / Mat Other - Missing - Yes / Overall Interior - Worn as per age - Yes / Overall Interior - Smell - Yes / Overall Interior - Animal Hair - Yes / Sunvisor, Sunglass Holder - Loose, Deformed - Small / Dashboard - Traces of Adhesive Tape - Yes / Dashboard - Worn, Scratch, Cut, Crack - Medium / Dashboard - Cigarette Burns - Burnt / (R) Front Seat - Grime - Medium / (L) Front Seat - Worn - Yes / Console, Switchs, Vents - Loose, Deformed - Small / Glove Box - Loose, Deformed - Small / Glove Box - Traces of Adhesive Tape - Yes / Steering Wheel - Worn, Peel, Crack - Medium / (L) Front Trim - Loose, Deformed - Medium / Display, Audio System - Missing - Yes / Rear Seat - Worn - Yes / Ceiling - Loose, Deformed - Large / Switchs - Missing - Yes / Room Mirror - Missing - Yes / Room Lamp - Missing - Yes</p>	<p>Remarks</p> <p>(R) Front Door - Repair Traces - Yes / (R) Front Fender - Repair Traces - Yes / Bonnet - Repair Traces - Yes / (L) Front Fender - Repair Traces - Yes / (L) Front Door - Repair Traces - Yes / (L) Rear Door - Repair Traces - Yes / (L) Rear Fender - Repair Traces - Yes / Trunk Hood, Rear Gate - Repair Traces - Yes / Rear End Panel - Repair Traces - Yes / (R) Rear Fender - Repair Traces - Yes / (R) Rear Door - Repair Traces - Yes / Roof - Repair Traces - Yes / Roof - Replaced - Yes / Trunk Hood, Rear Gate - Repair mark - Yes / (L) Rear Fender, Molding - Repair mark - Yes / (L) Rear Door, Molding - Repair mark - Yes / (L) Front Door, Molding - Repair mark - Yes / (L) Front Fender, Molding - Repair mark - Yes / Bonnet, Headlight - Repair mark - Yes / (R) Front Fender, Molding - Repair mark - Yes / (R) Front Door, Molding - Repair mark - Yes / (R) Rear Door, Molding - Repair mark - Yes / Front Bumper, Grille, Lamps - Repair mark - Yes / (R) Rear Fender, Molding - Repair mark - Yes / Rear Bumper, Lamps, Panels - Repair mark - Yes / (L) Step, In-panel, Side Spoiler - Repair mark - Yes / (R) Step, In-panel, Side Spoiler - Repair mark - Yes / Overall Exterior - Full Re-Paint in same color - Yes / Overall Exterior - Worn as per age - Yes / Overall Exterior - Re-Paint Uneven - Yes / (L) Rear Fender, Molding - Rust, Corrosion - Large / (L) Rear Door, Molding - Rust, Corrosion - Large / (L) Front Door, Molding - Rust, Corrosion - Large / (L) Front Fender, Molding - Scratch - Medium / Front Bumper, Grille, Lamps - Crack, Gap - Large / Bonnet, Headlight - Scratch - Small / (L) Mirror - Scratch - Minimal / (R) Mirror - Scratch - Minimal / (R) Front Fender, Molding - Scratch & Dent - Small / (R) Front Door, Molding - Rust, Corrosion - Small / (R) Rear Door, Molding - Scratch - Small / (R) Rear Fender, Molding - Scratch - Small / (R) Step, In-panel, Side Spoiler - Scratch & Dent - Small / (L) Step, In-panel, Side Spoiler - Scratch & Dent - Small / Roof - Scratch & Dent - Large / Trunk Hood, Rear Gate - Crack, Gap - Large / Rear Bumper, Lamps, Panels - Scratch - Small</p>
