General Information

Make	Toyota	Model	Vios
YOM	2023	Odo Meter Reading	23,524
Registration No.	NHI8297	Chassis No.	PA1B18F34P4211053
CC	1.3	Transmission	CVT
Fuel Type	Gas	Type of Body	Sedan
Colour	Silver

Body / Panel Condition

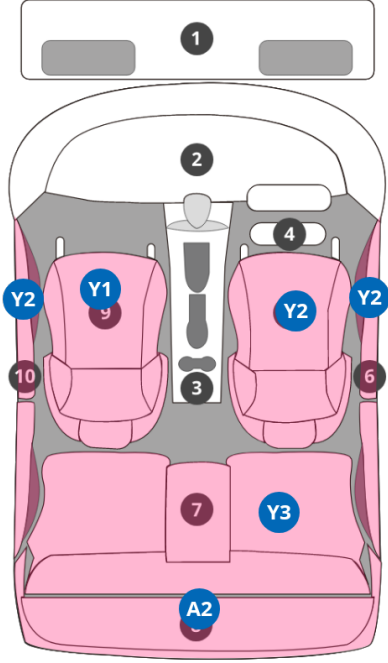
Interior Evaluation : B	Exterior Evaluation : C

<p>a : Cut, Fray d : Loose, Deformed k : Animal Hair s : Smell t : Cigarette Burns x : Defective y : Stain</p>

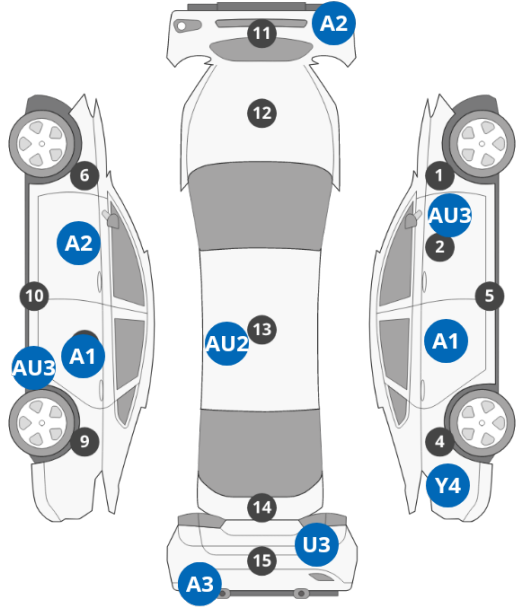
<p>A : Scratch AU : Scratch & Dent B : Modified C : Corrosion G : Stone chip P : Faded S : Rust SC : Rust & Corrosion U : Dent X : Defective Y : Crack, Gap</p>
<p>Remarks Rear Seat - Grime - Medium / (R) Front Trim - Grime - Small / (R) Front Seat - Grime - Small / Trunk Room - Worn, Scratch, Cut, Crack - Small / (L) Front Trim - Grime - Small / (L) Front Seat - Grime - Minimal</p>	<p>Remarks Trunk Hood, Rear Gate - Repair Traces - Yes / Trunk Hood, Rear Gate - Dent - Medium / Rear Bumper, Lamps, Panels - Scratch - Medium / (L) Rear Door, Molding - Scratch - Minimal / (L) Front Door, Molding - Scratch - Small / Front Bumper, Grille, Lamps - Scratch - Small / (R) Front Door, Molding - Scratch & Dent - Medium / (R) Rear Door, Molding - Scratch - Minimal / (R) Rear Fender, Molding - Crack, Gap - Large / (L) Step, In-panel, Side Spoiler - Scratch & Dent - Medium / Roof - Scratch & Dent - Small</p>
