General Information

Make	Hyundai	Model	Accent
YOM	2021	Odo Meter Reading	35,522
Registration No.	DAP1660	Chassis No.	PEHC841BBMH009615
CC	1.4	Transmission	A/T
Fuel Type	Gas	Type of Body	Sedan
Colour	Red

Body / Panel Condition

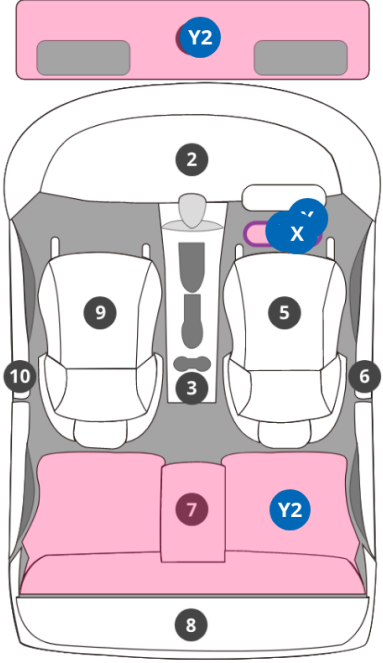
Interior Evaluation : B	Exterior Evaluation : B

<p>a : Cut, Fray d : Loose, Deformed k : Animal Hair s : Smell t : Cigarette Burns x : Defective y : Stain</p>

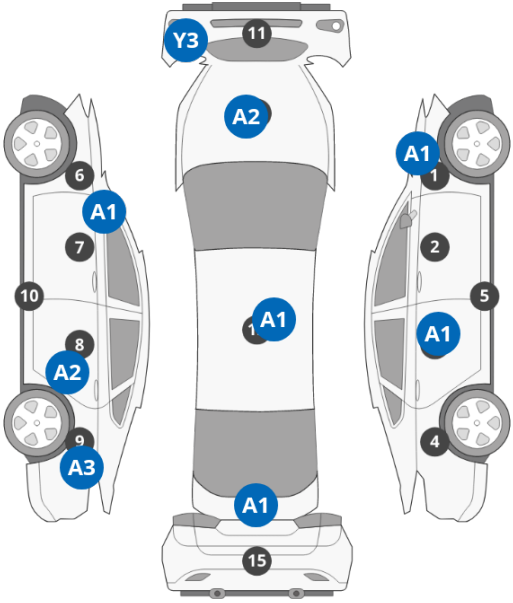
<p>A : Scratch AU : Scratch & Dent B : Modified C : Corrosion G : Stone chip P : Faded S : Rust SC : Rust & Corrosion U : Dent X : Defective Y : Crack, Gap</p>
<p>Remarks (L) Front Floor Mat - Missing - Yes / (R) Front Floor Mat - Missing - Yes / Mat Other - Missing - Yes / Ceiling - Grime - Small / Rear Seat - Grime - Small</p>	<p>Remarks Front Bumper, Grille, Lamps - Crack, Gap - Medium / Bonnet, Headlight - Scratch - Small / (R) Front Fender, Molding - Scratch - Minimal / (L) Rear Fender, Molding - Scratch - Medium / (L) Rear Door, Molding - Scratch - Small / (L) Mirror - Scratch - Minimal / Roof - Scratch - Minimal / Trunk Hood, Rear Gate - Scratch - Minimal / (R) Rear Door, Molding - Scratch - Minimal</p>
Frame Evaluation : A	Functional Evaluation : B

<p>Inspector Notes</p>
<p>With LTO plate and Sparetire and Jack and Incomplete Tools, No warranty booklet, scratch headlight and tail light, no spare key,</p>
