General Information

Make	Toyota	Model	Vios
YOM	2023	Odo Meter Reading	32,558
Registration No.	NHR2569	Chassis No.	PA1B18F30P4224172
CC	1.3	Transmission	CVT
Fuel Type	Gas	Type of Body	Sedan
Colour	Black

Body / Panel Condition

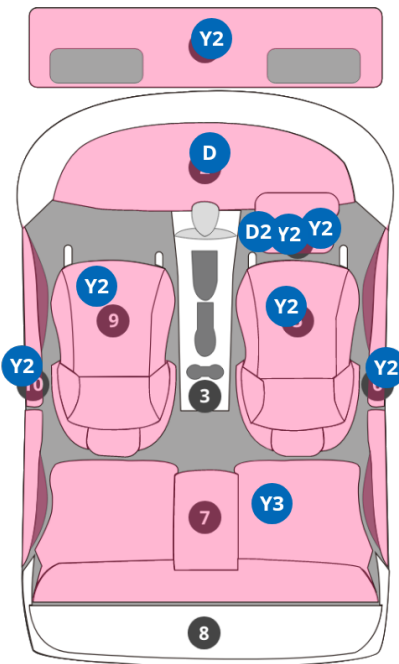
Interior Evaluation : C	Exterior Evaluation : E

<p>a : Cut, Fray d : Loose, Deformed k : Animal Hair s : Smell t : Cigarette Burns x : Defective y : Stain</p>

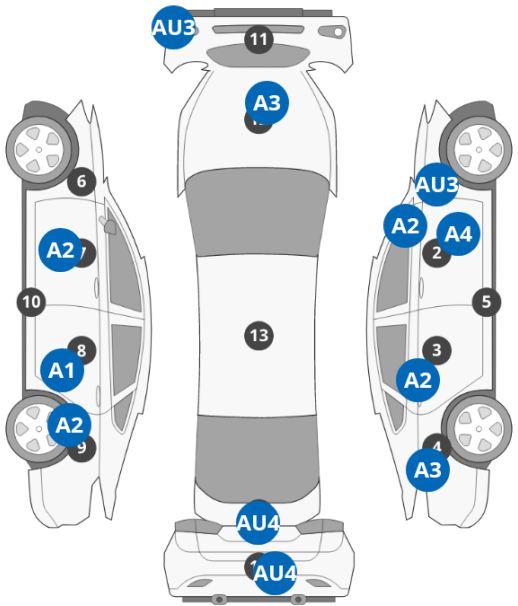
<p>A : Scratch AU : Scratch & Dent B : Modified C : Corrosion G : Stone chip P : Faded S : Rust SC : Rust & Corrosion U : Dent X : Defective Y : Crack, Gap</p>
<p>Remarks Ceiling - Grime - Small / (R) Front Trim - Grime - Small / (R) Front Floor Mat - Grime - Small / (R) Front Seat - Grime - Small / Rear Seat - Grime - Medium / Mat Other - Grime - Small / (L) Front Trim - Grime - Small / (L) Front Seat - Grime - Small / (L) Front Floor Mat - Worked - Small / Dashboard - Traces of Adhesive Tape - Yes</p>	<p>Remarks Trunk Hood, Rear Gate - Repair Traces - Yes / Rear End Panel - Repair Traces - Yes / Trunk Hood, Rear Gate - Scratch & Dent - Large / Rear Bumper, Lamps, Panels - Scratch & Dent - Large / (L) Rear Fender, Molding - Scratch - Small / (L) Front Door, Molding - Scratch - Small / (L) Rear Door, Molding - Scratch - Minimal / (R) Front Fender, Molding - Scratch & Dent - Medium / (R) Mirror - Scratch - Small / (R) Front Door, Molding - Scratch - Large / (R) Rear Door, Molding - Scratch - Small / (R) Rear Fender, Molding - Scratch - Medium / Front Bumper, Grille, Lamps - Scratch & Dent - Medium / Bonnet, Headlight - Scratch - Medium</p>

Inspector Notes
Damaged rear bumper and trunk door. Crack/gap at right taillight. With warranty booklet, spare tire and jack. Without tools and seat cover. 1 key. Temporary plate.
