General Information

Make	Mitsubishi	Model	Mirage
YOM	2023	Odo Meter Reading	19,800
Registration No.	DAX1500	Chassis No.	PAEA13RXPPA016594
CC	1.2	Transmission	CVT
Fuel Type	Gas	Type of Body	Sedan
Colour	Gray

Body / Panel Condition

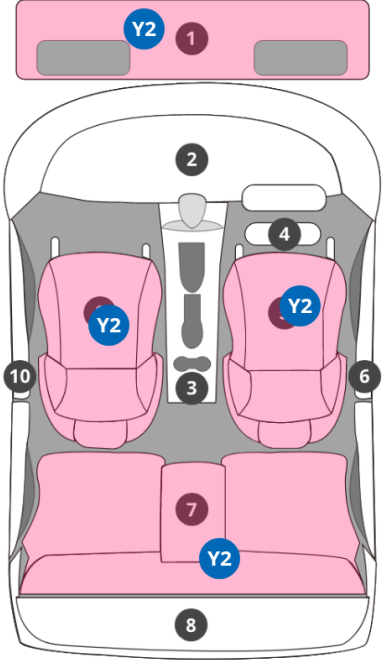
Interior Evaluation : A	Exterior Evaluation : C

<p>a : Cut, Fray d : Loose, Deformed k : Animal Hair s : Smell t : Cigarette Burns x : Defective y : Stain</p>

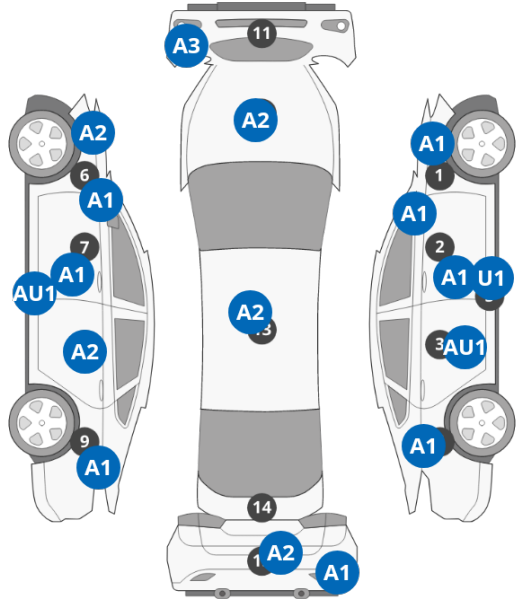
<p>A : Scratch AU : Scratch & Dent B : Modified C : Corrosion G : Stone chip P : Faded S : Rust SC : Rust & Corrosion U : Dent X : Defective Y : Crack, Gap</p>
<p>Remarks Ceiling - Grime - Small / (R) Front Seat - Grime - Small / (L) Front Seat - Grime - Small / Rear Seat - Grime - Small</p>	<p>Remarks Front Bumper, Grille, Lamps - Scratch - Medium / (L) Front Fender, Molding - Scratch - Small / (R) Front Fender, Molding - Scratch - Minimal / Bonnet, Headlight - Scratch - Small / (R) Mirror - Scratch - Minimal / (L) Mirror - Scratch - Minimal / Roof - Scratch - Small / (L) Front Door, Molding - Scratch - Minimal / (L) Rear Door, Molding - Scratch - Small / (L) Step, In-panel, Side Spoiler - Scratch & Dent - Minimal / (L) Rear Fender, Molding - Scratch - Minimal / (R) Front Door, Molding - Scratch - Minimal / (R) Rear Door, Molding - Scratch & Dent - Minimal / (R) Step, In-panel, Side Spoiler - Dent - Minimal / (R) Rear Fender, Molding - Scratch - Minimal / Trunk Hood, Rear Gate - Scratch - Small / Rear Bumper, Lamps, Panels - Scratch - Minimal</p>

<p>Inspector Notes</p>
<p>No LTO plate, Jack and Warranty booklet, No Tools, With Spare tire, Scratch headlight and tail light, Worn Tires, adhesive marks, No spare key.</p>
