General Information

Make	Toyota	Model	Wigo
YOM	2022	Odo Meter Reading	27,389
Registration No.	NIC1778	Chassis No.	MHKA4DF5FNJ070642
CC	1.0	Transmission	A/T
Fuel Type	Gas	Type of Body	Hatchback
Colour	Yellow

Body / Panel Condition

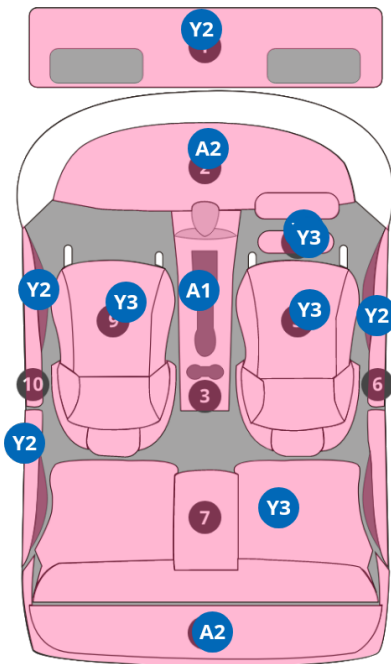
Interior Evaluation : D	Exterior Evaluation : D

<p>a : Cut, Fray d : Loose, Deformed k : Animal Hair s : Smell t : Cigarette Burns x : Defective y : Stain</p>

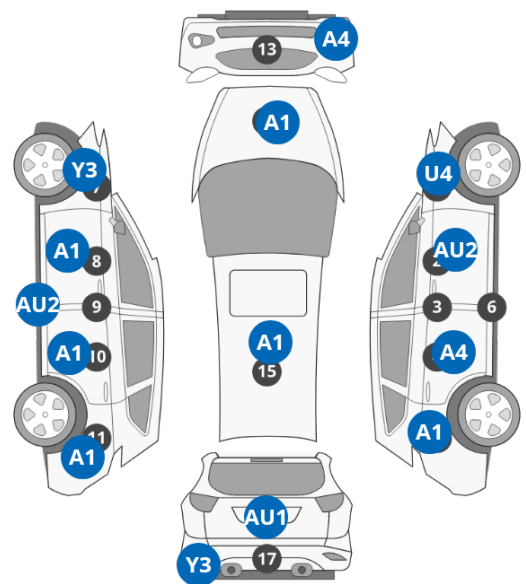
<p>A : Scratch AU : Scratch & Dent B : Modified C : Corrosion G : Stone chip P : Faded S : Rust SC : Rust & Corrosion U : Dent X : Defective Y : Crack, Gap</p>
<p>Remarks (R) Front Seat - Grime - Medium / Dashboard - Worn, Scratch, Cut, Crack - Small / (R) Front Floor Mat - Grime - Small / (R) Front Trim - Grime - Small / Rear Seat - Grime - Medium / Mat Other - Grime - Medium / Trunk Room - Worn, Scratch, Cut, Crack - Small / (L) Rear Trim - Grime - Small / (L) Front Trim - Grime - Small / (L) Front Seat - Grime - Medium / Ceiling - Grime - Small / Console, Switches, Vents - Worn, Scratch, Cut, Crack - Minimal</p>	<p>Remarks (L) Rear Door, Molding - Scratch - Minimal / (L) Front Door, Molding - Scratch - Minimal / (L) Step, In-panel, Side Spoiler - Scratch & Dent - Small / (L) Rear Fender, Molding - Scratch - Minimal / (L) Front Fender, Molding - Crack, Gap - Medium / Bonnet, Headlight - Scratch - Minimal / Front Bumper, Grille, Lamps - Scratch - Large / (R) Front Door, Molding - Scratch & Dent - Small / (R) Front Fender, Molding - Dent - Large / (R) Rear Door, Molding - Scratch - Large / Rear Bumper, Lamps, Panels - Crack, Gap - Medium / Trunk Hood, Rear Gate - Scratch & Dent - Minimal / (R) Rear Fender, Molding - Scratch - Minimal / Roof - Scratch - Minimal</p>
