General Information

Make	Toyota	Model	Innova
YOM	2024	Odo Meter Reading	27,401
Registration No.	NIU3561	Chassis No.	PA2JA8EM0P0134481
CC	2.8	Transmission	A/T
Fuel Type	Diesel	Type of Body	Wagon
Colour	Red Mica Metallic

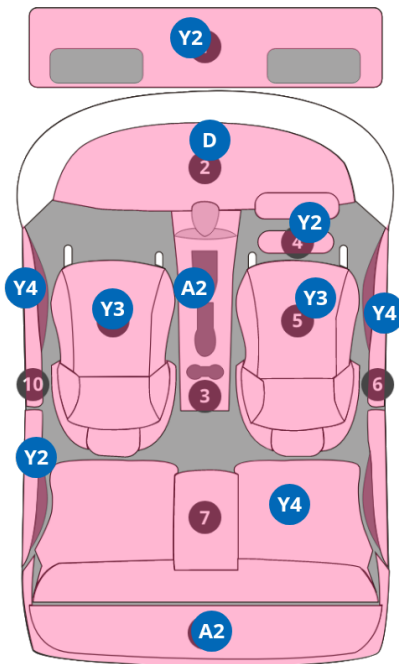
Interior Evaluation : E	Exterior Evaluation : D

<p>a : Cut, Fray d : Loose, Deformed k : Animal Hair s : Smell t : Cigarette Burns x : Defective y : Stain</p>
