General Information

Make	Toyota	Model	Lite Ace
YOM	2024	Odo Meter Reading	11,407
Registration No.	VAC1748	Chassis No.	MHKB3FE10PK003318
CC	1.5	Transmission	M/T
Fuel Type	Gas	Type of Body	Utility Cargo
Colour	White

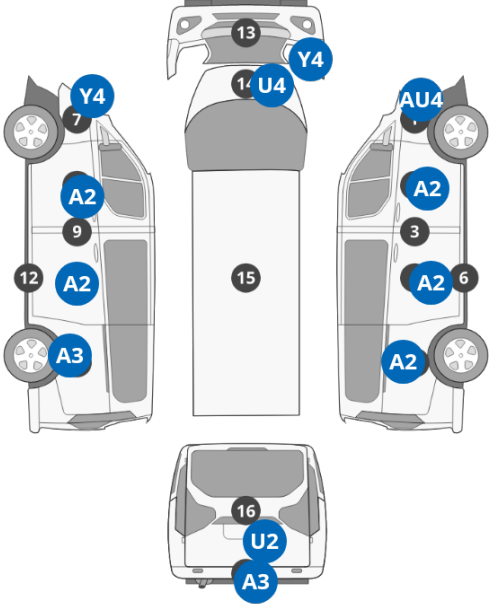
<p>A : Scratch AU : Scratch & Dent B : Modified C : Corrosion G : Stone chip P : Faded S : Rust SC : Rust & Corrosion U : Dent X : Defective Y : Crack, Gap</p>
Remarks (L) Rear Trim - Worked - Large / (R) Rear Trim - Worked - Large	Remarks (R) Front Fender, Molding - Scratch & Dent - Large / Bonnet, Headlight - Dent - Large / Front Bumper, Grille, Lamps - Crack, Gap - Large / (L) Front Fender, Molding - Crack, Gap - Large / (L) Front Door, Molding - Scratch - Small / (L) Rear Door, Molding - Scratch - Small / (L) Rear Fender, Molding - Scratch - Medium / Trunk Hood, Rear Gate - Dent - Small / Rear Bumper, Lamps, Panels - Scratch - Medium / (R) Rear Fender, Molding - Scratch - Small / (R) Rear Door, Molding - Scratch - Small / (R) Front Door, Molding - Scratch - Small
