## General Information

| Make | Toyota | Model | Vios |
| Registration No. | DBM8428 | Chassis No. | PA1B18F30R4246045 |

## Body / Panel Condition

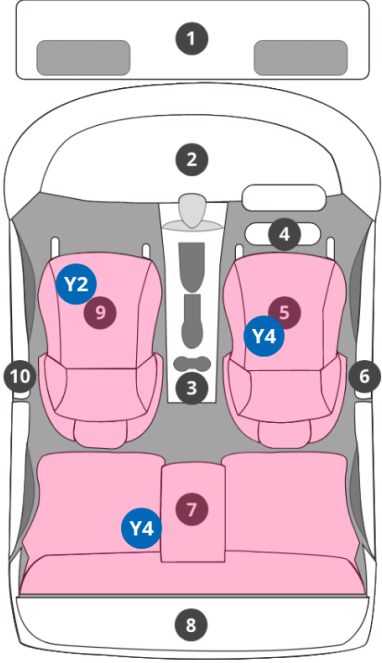
| Interior Evaluation : <span style="color: red;">C</span> | Exterior Evaluation : <span style="color: red;">E</span> |
| <b>Remarks</b><br>Rear Seat - Grime - Large / (L) Front Seat - Grime - Small / (R) Front Seat - Grime - Large | <b>Remarks</b><br>(L) Rear Door, Molding - Dent - Small / Rear Bumper, Lamps, Panels - Repair mark - Yes / Rear Bumper, Lamps, Panels - Scratch & Dent - Large / Trunk Hood, Rear Gate - Scratch & Dent - Medium / (R) Rear Door, Molding - Scratch - Large / (R) Step, In-panel, Side Spoiler - Scratch - Large / (R) Front Door, Molding - Scratch & Dent - Small / Bonnet, Headlight - Dent - Small / (L) Front Fender, Molding - Scratch - Minimal / (L) Front Door, Molding - Scratch - Small / (L) Rear Fender, Molding - Scratch - Minimal / (R) Front Fender, Molding - Scratch - Minimal / Front Bumper, Grille, Lamps - Scratch & Dent - Large / (R) Rear Fender, Molding - Scratch & Dent - Small / (R) Front Tyre - Crack, Cut - Yes |
