## General Information

| Make | Toyota | Model | Vios |
| YOM | 2024 | Odo Meter Reading | 10,796 |

## Body / Panel Condition

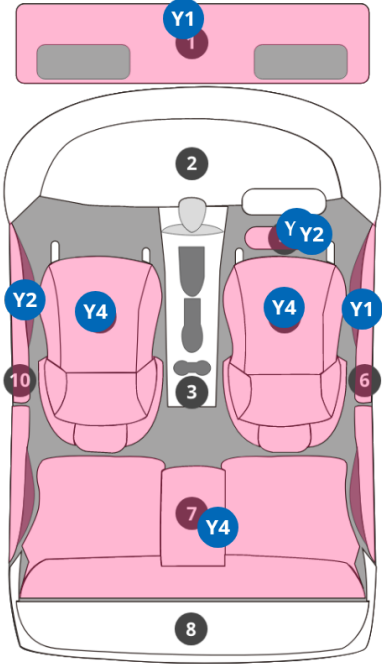
| Interior Evaluation : <span>C</span> | Exterior Evaluation : <span>C</span> |
| <p><b>Remarks</b></p> <p>(R) Front Trim - Grime - Minimal / (R) Front Seat - Grime - Large / Rear Seat - Grime - Large / (L) Front Trim - Grime - Small / (L) Front Seat - Grime - Large / (R) Front Floor Mat - Grime - Minimal / (L) Front Floor Mat - Grime - Small / Ceiling - Grime - Minimal</p> | <p><b>Remarks</b></p> <p>(R) Rear Door, Molding - Scratch &amp; Dent - Large / (R) Step, In-panel, Side Spoiler - Scratch - Medium / (R) Rear Fender, Molding - Scratch - Small / Rear Bumper, Lamps, Panels - Scratch - Small / Trunk Hood, Rear Gate - Scratch - Minimal / Roof - Scratch - Small / (L) Rear Fender, Molding - Scratch - Minimal / (L) Mirror - Scratch - Small / (L) Step, In-panel, Side Spoiler - Crack, Gap - Small / Front Bumper, Grille, Lamps - Scratch - Medium / (R) Front Door, Molding - Scratch - Minimal / (L) Front Door, Molding - Scratch - Minimal</p> |
