## General Information

| Make | Toyota | Model | Vios |
| YOM | 2025 | Odo Meter Reading | 30,007 |
| Registration No. | DBR5546 | Chassis No. | PA1B18F37R4274327 |

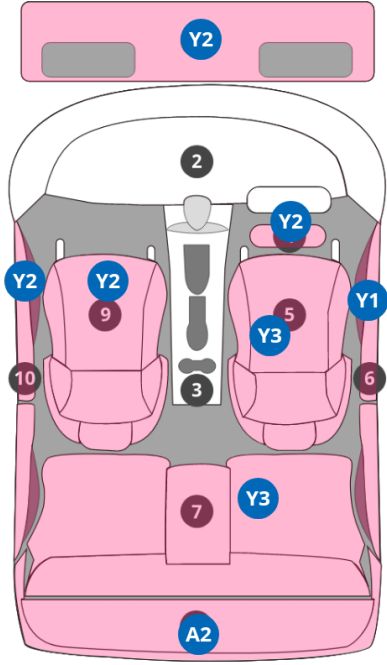
| Interior Evaluation : <b>C</b> | Exterior Evaluation : <b>C</b> |
| <p><b>Remarks</b></p> <p>Rear Seat - Grime - Medium / (R) Front Trim - Grime - Minimal / (R) Front Seat - Grime - Medium / Trunk Room - Worn, Scratch, Cut, Crack - Small / (L) Front Floor Mat - Grime - Small / (L) Front Seat - Grime - Small / (L) Front Trim - Grime - Small / Ceiling - Grime - Small</p> | <p><b>Remarks</b></p> <p>(L) Front Door, Molding - Scratch - Medium / (L) Rear Door, Molding - Scratch - Minimal / (L) Front Fender, Molding - Scratch - Small / Front Bumper, Grille, Lamps - Scratch - Medium / Bonnet, Headlight - Scratch - Minimal / (R) Front Fender, Molding - Scratch - Small / (R) Mirror - Scratch - Minimal / (R) Front Door, Molding - Scratch - Minimal / (R) Rear Door, Molding - Scratch - Small / (R) Rear Fender, Molding - Scratch - Small / Rear Bumper, Lamps, Panels - Scratch - Small / Trunk Hood, Rear Gate - Scratch - Minimal / (L) Rear Fender, Molding - Scratch - Minimal / Roof - Scratch - Minimal</p> |
