## General Information

| Make | Toyota | Model | Wigo |
| YOM | 2024 | Odo Meter Reading | 6,526 |

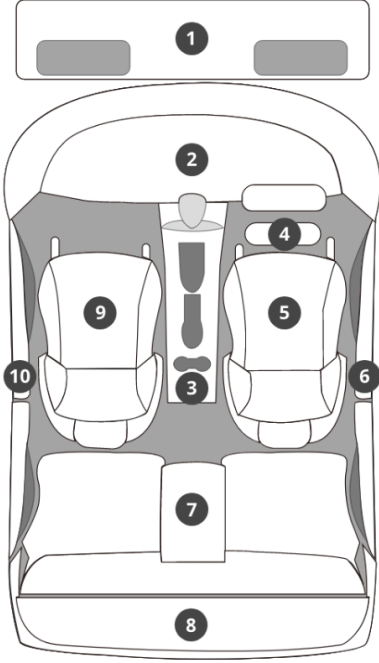
| Interior Evaluation : <span style="color: red; font-weight: bold;">A</span> | Exterior Evaluation : <span style="color: red; font-weight: bold;">D</span> |
| <b>Remarks</b><br>Defects not found | <b>Remarks</b><br>Bonnet, Headlight - Scratch - Large / (R) Rear Fender, Molding - Scratch - Large / (R) Rear Door, Molding - Scratch - Medium / (R) Front Door, Molding - Scratch - Small / (R) Front Fender, Molding - Scratch - Small / Front Bumper, Grille, Lamps - Scratch - Small / (L) Front Fender, Molding - Scratch - Small / (L) Rear Door, Molding - Scratch - Small / (L) Front Door, Molding - Scratch - Small / Rear Bumper, Lamps, Panels - Scratch - Small / Trunk Hood, Rear Gate - Scratch - Small |

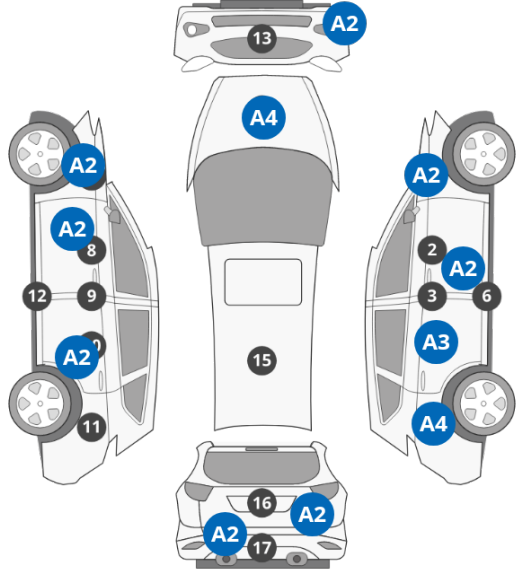
| Inspector Notes |
|---|
| with jack and spare tire/ with tools and LTO plate/ no warranty booklet/ paint marks all over the vehicle |
