## General Information

| Make | Toyota | Model | Fortuner |
| YOM | 2022 | Odo Meter Reading | 19,803 |

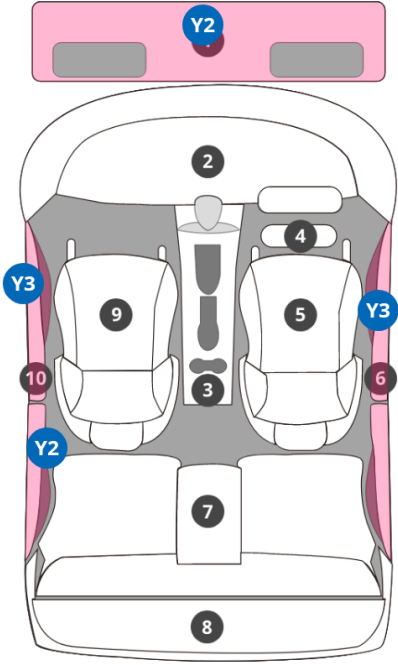
| Interior Evaluation : <b>B</b> | Exterior Evaluation : <b>B</b> |
| <b>Remarks</b><br>(R) Front Trim - Grime - Medium / (L) Rear Trim - Grime - Small / (L) Front Trim - Grime - Medium / Ceiling - Grime - Small | <b>Remarks</b><br>(R) Rear Door, Molding - Scratch - Minimal / Front Bumper, Grille, Lamps - Scratch - Small / (L) Step, In-panel, Side Spoiler - Scratch - Minimal / (L) Rear Door, Molding - Scratch - Minimal / Rear Bumper, Lamps, Panels - Scratch - Minimal / (R) Rear Fender, Molding - Scratch - Minimal / (R) Front Fender, Molding - Dent - Medium / (R) Mirror - Scratch - Minimal |
