## General Information

| Make | Toyota | Model | Vios |
| YOM | 2021 | Mileage | 69,462 |
| Registration No. | NEX4823 | Chassis No. | PA1B18F3XM4142512 |

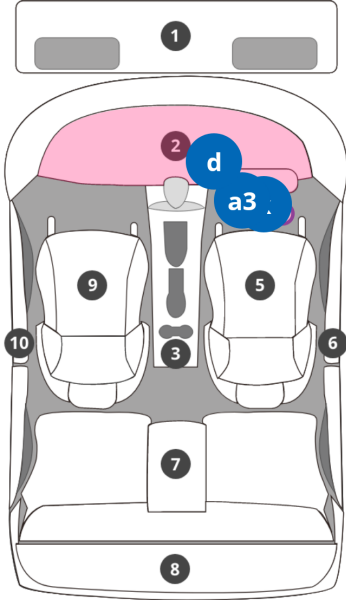
| Interior Evaluation : <b>B</b> | Exterior Evaluation : <b>D</b> |
| <b>Remarks</b><br>(R) Front Floor Mat - Missing - Yes / (L) Front Floor Mat - Cut, Crack - Medium / Dashboard - Traces of Adhesive Tape - Yes | <b>Remarks</b><br>(R) Front Fender, Molding - Scratch & Dent - Large / (R) Front Door, Molding - Scratch & Dent - Medium / (R) Step, In-panel, Side Spoiler - Scratch & Dent - Large / (R) Rear Door, Molding - Scratch & Dent - Medium / (R) Rear Fender, Molding - Scratch & Dent - Small / Rear Bumper, Lamps, Panels - Scratch - Large / (L) Front Door, Molding - Scratch & Dent - Small / (L) Front Fender, Molding - Scratch - Small / (R) Mirror - Scratch - Small |
