## General Information

| Make | Toyota | Model | Avanza |
| Registration No. | NHI6553 | Chassis No. | MHFAA1BY1P0013171 |

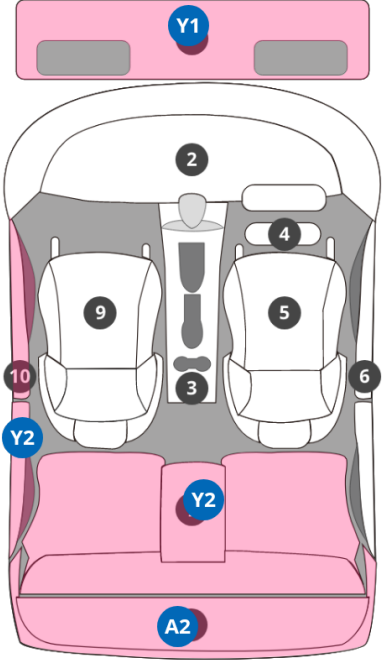
| Interior Evaluation : <b>A</b> | Exterior Evaluation : <b>E</b> |
|---|---|
| <b>Remarks</b><br>Rear Seat - Grime - Small / Trunk Room - Worn, Scratch, Cut, Crack - Small / (L) Rear Trim - Grime - Small / Ceiling - Grime - Minimal | <b>Remarks</b><br>Roof - Dent - Small / Trunk Hood, Rear Gate - Dent - Medium / (L) Rear Door, Molding - Repair mark - Yes / Rear Bumper, Lamps, Panels - Repair mark - Yes / Rear Bumper, Lamps, Panels - Scratch - Medium / (R) Rear Door, Molding - Scratch & Dent - Small / (R) Front Door, Molding - Scratch & Dent - Small / (R) Front Door, Molding - Repair mark - Yes / (R) Step, In-panel, Side Spoiler - Scratch & Dent - Medium / (R) Front Fender, Molding - Dent - Large / Bonnet, Headlight - Scratch - Minimal / (L) Front Door, Molding - Dent - Small / (L) Mirror - Scratch - Minimal / (L) Rear Door, Molding - Scratch - Small / (L) Rear Fender, Molding - Scratch & Dent - Small / (R) Rear Fender, Molding - Scratch & Dent - Minimal / (R) Mirror - Scratch - Minimal / Front Bumper, Grille, Lamps - Scratch - Small / (L) Front Fender, Molding - Scratch - Minimal |
