## General Information

| Make | Toyota | Model | Avanza |

## Body / Panel Condition

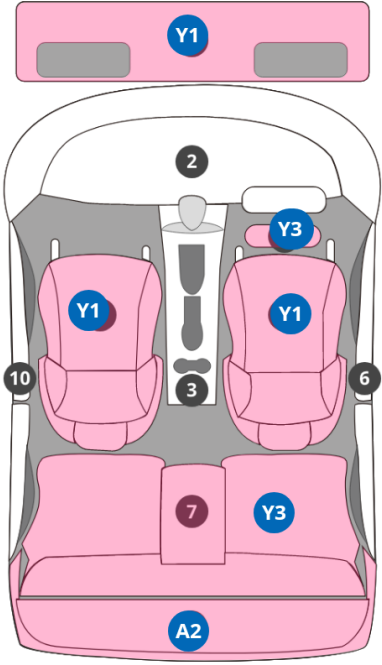
| Interior Evaluation : <b>B</b> | Exterior Evaluation : <b>C</b> |
|---|---|
| <b>Remarks</b><br>(R) Front Floor Mat - Grime - Small / Rear Seat - Grime - Medium / Trunk Room - Worn, Scratch, Cut, Crack - Small / Mat Other - Grime - Medium / Ceiling - Grime - Minimal / (R) Front Seat - Grime - Minimal / (L) Front Seat - Grime - Minimal | <b>Remarks</b><br>(R) Rear Fender, Molding - Scratch & Dent - Minimal / (R) Step, In-panel, Side Spoiler - Scratch - Minimal / (R) Front Door, Molding - Scratch & Dent - Medium / (R) Mirror - Scratch - Minimal / Front Bumper, Grille, Lamps - Scratch - Medium / (L) Front Fender, Molding - Dent - Small / (L) Front Door, Molding - Scratch - Minimal / (L) Rear Door, Molding - Scratch - Small / (L) Rear Fender, Molding - Scratch - Minimal / Trunk Hood, Rear Gate - Scratch - Minimal / Rear Bumper, Lamps, Panels - Scratch - Minimal / (R) Rear Door, Molding - Scratch - Minimal / Roof - Scratch - Minimal / Bonnet, Headlight - Scratch - Minimal |
