General Information

Make	Toyota	Model	Vios
YOM	2021	Odo Meter Reading	36,070
Registration No.	NGB2598	Chassis No.	PA1B18F34L4120567
CC	1.3	Transmission	CVT
Fuel Type	Gas	Type of Body	Sedan
Colour	Red Mica Metallic

Body / Panel Condition

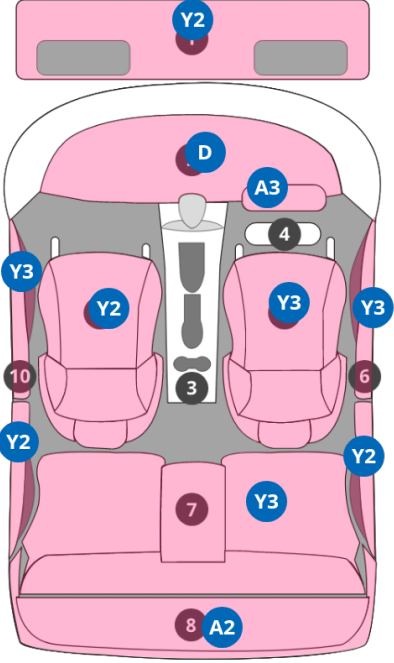
Interior Evaluation : D	Exterior Evaluation : E

<p>a : Cut, Fray d : Loose, Deformed k : Animal Hair s : Smell t : Cigarette Burns x : Defective y : Stain</p>

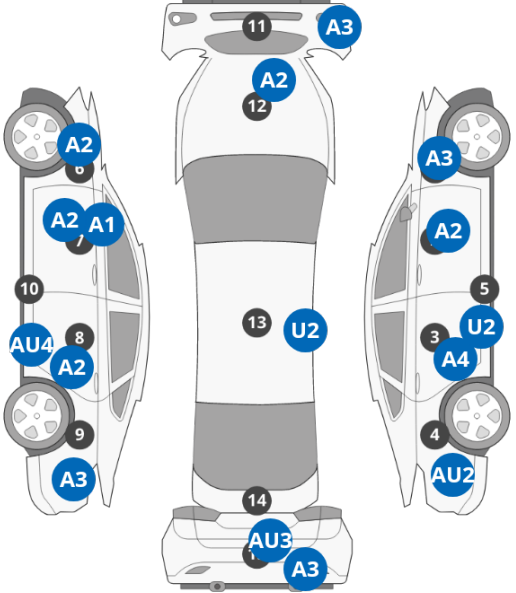
<p>A : Scratch AU : Scratch & Dent B : Modified C : Corrosion G : Stone chip P : Faded S : Rust SC : Rust & Corrosion U : Dent X : Defective Y : Crack, Gap</p>
<p>Remarks Trunk Room - Worn, Scratch, Cut, Crack - Small / Rear Seat - Grime - Medium / (R) Rear Trim - Grime - Small / (R) Front Trim - Grime - Medium / (R) Front Seat - Grime - Medium / (L) Rear Trim - Grime - Small / (L) Front Trim - Grime - Medium / Steering Wheel - Worn, Peel, Crack - Medium / (L) Front Seat - Grime - Small / Ceiling - Grime - Small / Dashboard - Traces of Adhesive Tape - Yes</p>	<p>Remarks (L) Mirror - Scratch - Minimal / (L) Front Door, Molding - Scratch - Small / (L) Front Fender, Molding - Scratch - Small / (L) Rear Door, Molding - Scratch - Small / (L) Step, In-panel, Side Spoiler - Scratch & Dent - Large / (L) Rear Fender, Molding - Scratch - Medium / Trunk Hood, Rear Gate - Scratch & Dent - Medium / Rear Bumper, Lamps, Panels - Scratch - Medium / (R) Rear Fender, Molding - Scratch & Dent - Small / (R) Rear Door, Molding - Scratch - Large / (R) Step, In-panel, Side Spoiler - Dent - Small / (R) Front Door, Molding - Scratch - Small / (R) Front Fender, Molding - Scratch - Medium / Bonnet, Headlight - Scratch - Small / Front Bumper, Grille, Lamps - Scratch - Medium / Roof - Dent - Small</p>
