## General Information

<b>Make</b>	Toyota	<b>Model</b>	Vios
<b>YOM</b>	2025	<b>Odo Meter Reading</b>	10,495
<b>Registration No.</b>	CCJ3920	<b>Chassis No.</b>	PA1B18F30R4275285
<b>CC</b>	1.3	<b>Transmission</b>	CVT
<b>Fuel Type</b>	Gas	<b>Type of Body</b>	Sedan
<b>Colour</b>	Red

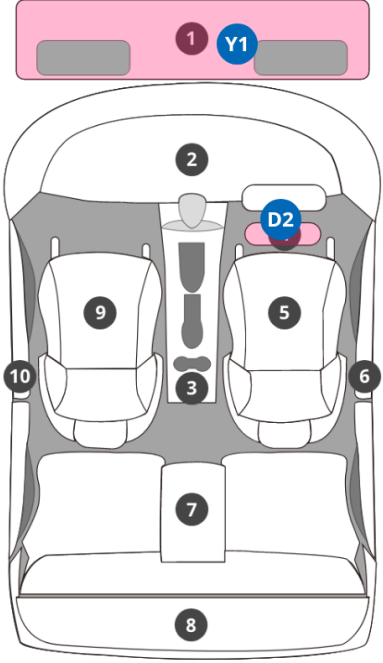
<b>Interior Evaluation :</b> <span style="float: right; color: red; font-weight: bold;">A</span>	<b>Exterior Evaluation :</b> <span style="float: right; color: red; font-weight: bold;">D</span>

<p><b>a</b> : Cut, Fray <b>d</b> : Loose, Deformed <b>k</b> : Animal Hair <b>s</b> : Smell <b>t</b> : Cigarette Burns <b>x</b> : Defective <b>y</b> : Stain</p>

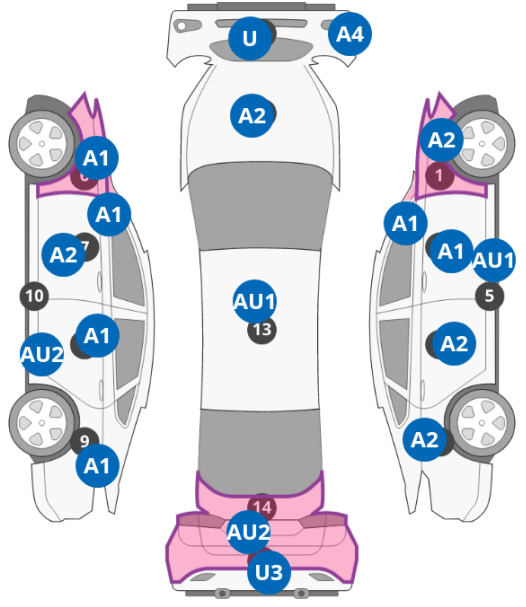
<p><b>A</b> : Scratch <b>AU</b> : Scratch &amp; Dent <b>B</b> : Modified <b>C</b> : Corrosion <b>G</b> : Stone chip <b>P</b> : Faded <b>S</b> : Rust <b>SC</b> : Rust &amp; Corrosion <b>U</b> : Dent <b>X</b> : Defective <b>Y</b> : Crack, Gap</p>
<b>Remarks</b> (L) Front Floor Mat - Worked - Small / Ceiling - Grime - Minimal	<b>Remarks</b> (R) Front Fender - Repair Traces - Yes / (L) Front Fender - Repair Traces - Yes / Trunk Hood, Rear Gate - Repair Traces - Yes / Front Bumper, Grille, Lamps - Scratch - Large / (L) Front Fender, Molding - Repair mark - Yes / (R) Front Fender, Molding - Repair mark - Yes / Trunk Hood, Rear Gate - Repair mark - Yes / (R) Front Fender, Molding - Scratch - Small / Member (Bolted) - Dent - Yes / Bonnet, Headlight - Scratch - Small / (R) Front Door, Molding - Scratch - Minimal / (R) Rear Door, Molding - Scratch - Small / (R) Step, In-panel, Side Spoiler - Scratch & Dent - Minimal / (R) Rear Fender, Molding - Scratch - Small / Rear Bumper, Lamps, Panels - Dent - Medium / Trunk Hood, Rear Gate - Scratch & Dent - Small / (L) Rear Fender, Molding - Scratch - Minimal / (L) Rear Door, Molding - Scratch - Minimal / (L) Front Door, Molding - Scratch - Small / (L) Step, In-panel, Side Spoiler - Scratch & Dent - Small / (L) Mirror - Scratch - Minimal / (L) Front Fender, Molding - Scratch - Minimal / Roof - Scratch & Dent - Minimal / (R) Mirror - Scratch - Minimal
