General Information

Body / Panel Condition

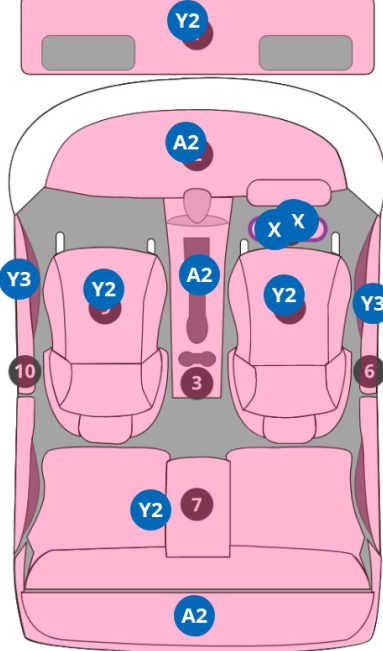
Interior Evaluation : C	Exterior Evaluation : C

<p>a : Cut, Fray d : Loose, Deformed k : Animal Hair s : Smell t : Cigarette Burns x : Defective y : Stain</p>

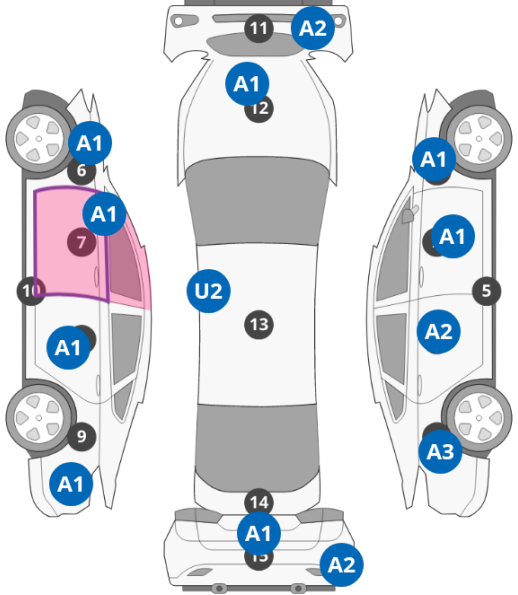
<p>A : Scratch AU : Scratch & Dent B : Modified C : Corrosion G : Stone chip P : Faded S : Rust SC : Rust & Corrosion U : Dent X : Defective Y : Crack, Gap</p>
<p>Remarks (R) Front Trim - Grime - Medium / Rear Seat - Grime - Small / (L) Front Trim - Grime - Medium / (R) Front Floor Mat - Missing - Yes / (L) Front Floor Mat - Missing - Yes / Mat Other - Missing - Yes / Ceiling - Grime - Small / (L) Front Seat - Grime - Small / (R) Front Seat - Grime - Small / Dashboard - Worn, Scratch, Cut, Crack - Small / Trunk Room - Worn, Scratch, Cut, Crack - Small / Console, Switches, Vents - Worn, Scratch, Cut, Crack - Small</p>	<p>Remarks (R) Front Door - Repair Traces - Yes / (L) Front Fender - Repair Traces - Yes / (L) Front Door - Repair Traces - Yes / (R) Rear Door - Repair Traces - Yes / Roof - Repair Traces - Yes / (L) Front Door, Molding - Repair mark - Yes / (L) Rear Door, Molding - Scratch - Minimal / Rear Bumper, Lamps, Panels - Scratch - Small / Trunk Hood, Rear Gate - Scratch - Minimal / (R) Rear Fender, Molding - Scratch - Medium / (R) Rear Door, Molding - Scratch - Small / (R) Front Fender, Molding - Scratch - Minimal / (R) Front Door, Molding - Scratch - Minimal / Front Bumper, Grille, Lamps - Scratch - Small / (L) Front Fender, Molding - Scratch - Minimal / (L) Mirror - Scratch - Minimal / Roof - Dent - Small / (L) Rear Fender, Molding - Scratch - Minimal / Bonnet, Headlight - Scratch - Minimal</p>
