General Information

Make	Toyota	Model	Vios
YOM	2023	Odo Meter Reading	14,893
Registration No.	NHJ7106	Chassis No.	PA1B18F36P4221339
CC	1.3	Transmission	CVT
Fuel Type	Gas	Type of Body	Sedan
Colour	White

Body / Panel Condition

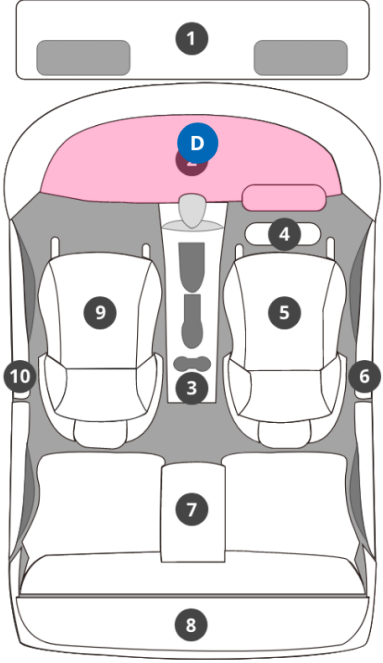
Interior Evaluation : A	Exterior Evaluation : E

<p>a : Cut, Fray d : Loose, Deformed k : Animal Hair s : Smell t : Cigarette Burns x : Defective y : Stain</p>

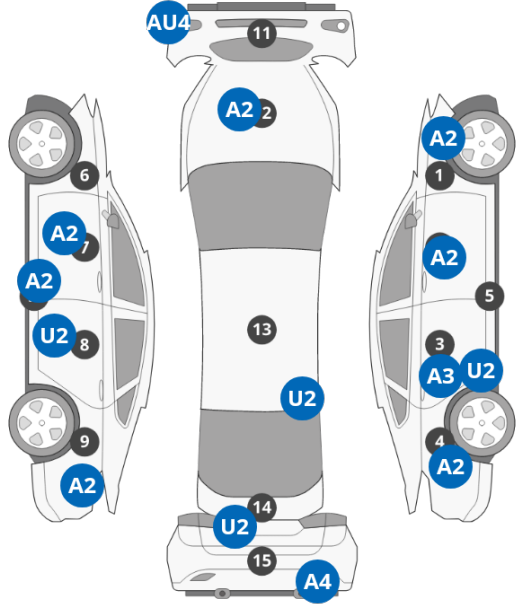
<p>A : Scratch AU : Scratch & Dent B : Modified C : Corrosion G : Stone chip P : Faded S : Rust SC : Rust & Corrosion U : Dent X : Defective Y : Crack, Gap</p>
Remarks Dashboard - Traces of Adhesive Tape - Yes	Remarks (R) Step - Repair Traces - Yes / (R) Rear Fender - Repair Traces - Yes / (R) Rear Door - Repair Traces - Yes / Trunk Hood, Rear Gate - Dent - Small / Roof - Dent - Small / Rear Bumper, Lamps, Panels - Scratch - Large / (R) Step, In-panel, Side Spoiler - Dent - Small / (R) Rear Door, Molding - Scratch - Medium / Front Bumper, Grille, Lamps - Scratch & Dent - Large / (L) Rear Door, Molding - Dent - Small / (L) Front Door, Molding - Scratch - Small / (R) Front Door, Molding - Scratch - Small / (R) Front Fender, Molding - Scratch - Small / (L) Rear Fender, Molding - Scratch - Small / (R) Rear Fender, Molding - Scratch - Small / Bonnet, Headlight - Scratch - Small / (L) Step, In-panel, Side Spoiler - Scratch - Small
