## General Information

| Make | Toyota | Model | Vios |
| Registration No. | NIO2353 | Chassis No. | PA1B18F37P4215615 |

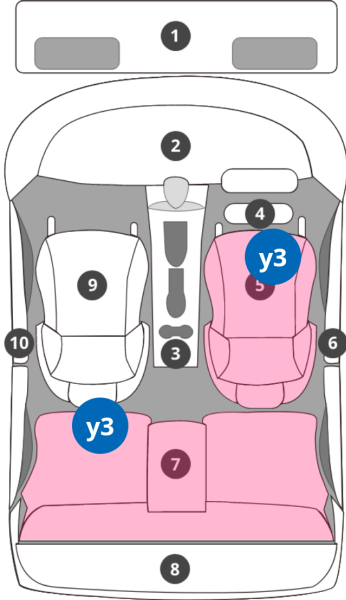
| Interior Evaluation : <b>B</b> | Exterior Evaluation : <b>D</b> |
| <b>Remarks</b><br>Rear Seat - Grime - Medium / (R) Front Seat - Grime - Medium | <b>Remarks</b><br>Member (Bolted) - Dent - Yes / Front Bumper, Grille, Lamps - Scratch - Medium / (L) Front Fender, Molding - Scratch & Dent - Large / (L) Front Door, Molding - Scratch & Dent - Large / (L) Rear Door, Molding - Scratch & Dent - Large / (L) Rear Fender, Molding - Scratch & Dent - Large / Rear Bumper, Lamps, Panels - Scratch - Medium / (R) Rear Door, Molding - Dent - Medium |

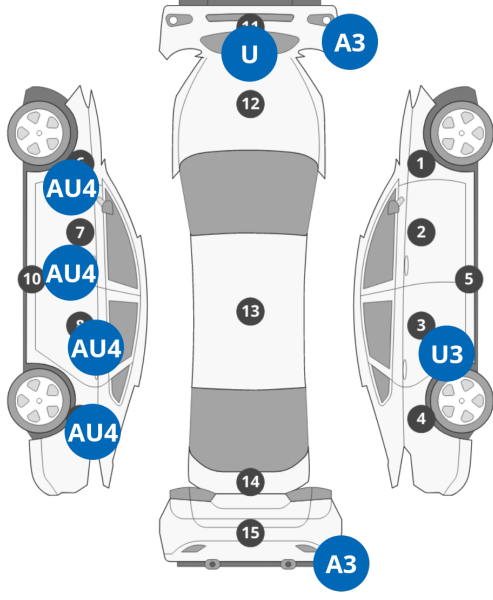
| Inspector Notes |
|---|
| left rear door window cannot be opened fully due to the damage of the door/ left rear door cannot be opened/ no spare tire/ no tools/ with warranty booklet/ with jack |
